Access Compliance Report Public Rights-of-Way (Curb Ramps)

Intersection ID: 10035098 Main Street: PROVIDENCE_RETREAT_LN Cross Street: N/A Location: E

ADA ID: AB8374DD88D5 Ramp Type: Perp Initial Pass/Fail: Fail Overall Compliance: No Severity Score: 8.75

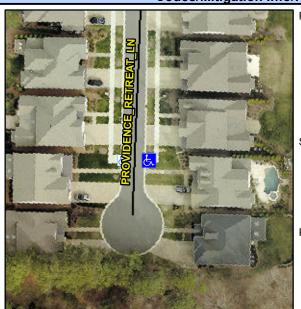
Comp	liance Description	Data			Description	Data
N/A	Ramp Length (in)	96.0	Yes	Ramp	Slope (%)	5.1
No	Ramp Width (in)	47.0	Yes	Ramp	XSlope (%)	1.4
N/A	Flare Type LT	N/A	N/A	Flare	Type RT	N/A
N/A	Flare Slope LT (%)	N/A	N/A	Flare	Slope RT (%)	N/A
N/A	Flare Traversable LT?	N/A	N/A	Flare	Traversable RT?	N/A
N/A	Landing Length (in)	N/A	N/A	DWS	Provided?	N/A
N/A	Landing Width (in)	N/A	N/A	DWS	Contrast?	N/A
N/A	Landing Slope (%)	N/A	N/A	DWS	Length (in)	N/A
N/A	Landing X Slope (%)	N/A	N/A	DWS	Full Width?	N/A
N/A	Landing Curb? (Y/N)	N/A	N/A	DWS	Offset (in)	N/A
N/A	Shared Landing?	N/A				
N/A	Gutter Ponding?	N/A	N/A	Gutte	r Slope (%)	N/A
N/A	Gutter Lip Ht (in)	N/A	N/A	Gutte	r X Slope (%)	N/A
N/A	Painted X Walk1?	No	N/A	Painte	ed X Walk2?	N/A
	X Walk 1 Direction	To W		X Wa	lk 2 Direction	N/A
N/A	X Walk 1 Width (in)	N/A	N/A	X Wa	lk 2 Width (in)	N/A
	X Walk 1 Slope (%)	3.6		X Wa	lk 2 Slope (%)	N/A
	X Walk 1 X Slope (%)	2.6		X Wa	lk 2 X Slope (%)	N/A

N/A	Ramp inside XWalk1?	N/A	N/A	Ramp	inside XWalk2?	N/A
	Road Slope (%)	N/A	N/A	Clear	Space?	N/A
	Road X Slope (%)	N/A	N/A	Clear	Space to XWalk (in)	N/A
N/A	Any Obstructions?	N/A	N/A	Storm	n Grate/Utility Hazard?	N/A
	Obstruction Type			Storm	n Grate/Utility Type	
		N/A				N/A
			Yes	Surfa	ce Condition? (G/P)	Good

Possible Solutions:	Co		
Remove & Replace Entire Ramp.			
	No		
	N/		
Surveyor Notes:	N/		
N/A	N/		
	N/		
	N/		
	N/		
PROW/ADA:	N/		
Not Found, R304.5.1	N/		
	N/		
	N/		
	N/

Total Cost: \$ 1850.00
