Access Compliance Report

Public Rights-of-Way

(Curb Ramps)

Intersection ID: 17333	Main Street: AUTUMN_RAIN_LN	Cross Street: CONSTABLE_CT	Location: NW
ADA ID: AB83E1FF5374	Ramp Type: PerpDiag	Initial Pass/Fail: Fail	Overall Compliance: No
Codes/Mitigation Info/Possible Solution		Field Measurements/Component Compliance

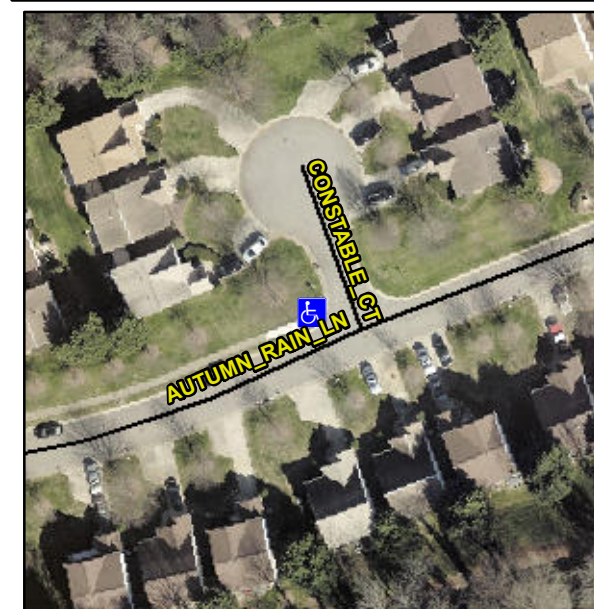
Not Found, R304.2.2, R304.5.3

Compliance	Description	Data	Compliance	Description	Data
N/A	Ramp Length (in)	49.0	No	Ramp Slope (%)	11.2
Yes	Ramp Width (in)	48.0	No	Ramp XSlope (%)	4.3
N/A	Flare Type LT	N/A	N/A	Flare Type RT	N/A
N/A	Flare Slope LT (%)	N/A	N/A	Flare Slope RT (%)	N/A
N/A	Flare Traversable LT?	N/A	N/A	Flare Traversable RT?	N/A
N/A	Landing Length (in)	N/A	N/A	DWS Provided?	N/A
N/A	Landing Width (in)	N/A	N/A	DWS Contrast?	N/A
N/A	Landing Slope (%)	N/A	N/A	DWS Length (in)	N/A
N/A	Landing X Slope (%)	N/A	N/A	DWS Full Width?	N/A
N/A	Landing Curb? (Y/N)	N/A	N/A	DWS Offset (in)	N/A
N/A	Shared Landing?	N/A			
N/A	Gutter Ponding?	N/A	N/A	Gutter Slope (%)	N/A
N/A	Gutter Lip Ht (in)	N/A	N/A	Gutter X Slope (%)	N/A
N/A	Painted X Walk1?	No	N/A	Painted X Walk2?	No
	X Walk 1 Direction	To S		X Walk 2 Direction	To E
N/A	X Walk 1 Width (in)	N/A	N/A	X Walk 2 Width (in)	N/A
	X Walk 1 Slope (%)	3.1		X Walk 2 Slope (%)	4.7
	X Walk 1 X Slope (%)	4.6		X Walk 2 X Slope (%)	1.3

Possible Solutions:

Remove & Replace Curb Ramp With Two New Directional Ramps or Equivalent.
