## Access Compliance Report Public Rights-of-Way (Curb Ramps)

| | | | ` | <u> </u> | , | | | | | |
|--|--|---|---|---|--|---|---|---|---|---|
| Intersection ID: 10011027 | Main Stre | Main Street: BLACKHAWK_RD | | | Street: | N/A | Location: | S | | |
| ADA ID: AB8C92C56282 | Ramp Ty | Ramp Type: Perp | | | Initial Pass/Fail: Pass Overall Compliance: No | | | | o Severity Score: | 22.5 |

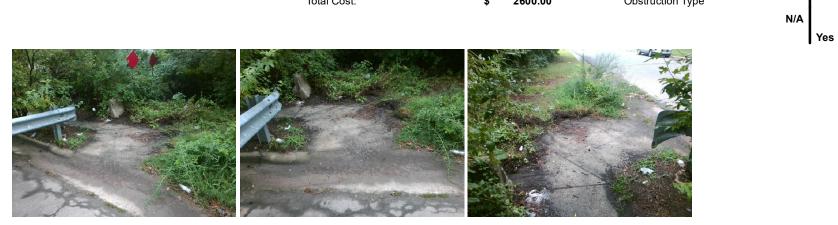
| | | | ` | <u> </u> | , | | | | | |
|--|--|---|---|---|--|---|---|---|---|---|
| | D | | | | Yes | Landing Length (in) | 60.0 | No | DWS Provided? | No |
| BLAU E | A Ser | N/A | | | No | Landing Slope (%) | 3.4 | N/A | DWS Length (in) | N/A |
| | KIN TE | PROW/ADA: | | | No | Gutter Ponding? | Yes | No | Gutter Slope (%) | 7.0 |
| | ALL A | Not Found, R304.2 | 2.2-Perp. R304 | .3.2- | No | Gutter Lip Ht (in) | 0.5 | Yes | Gutter X Slope (%) | 0.2 |

| | | | ` | <u> </u> | , | | | | | |
|--|--|---|---|---|--|---|---|---|---|---|
| Mar Walker Col | | Remove & Replace | e Entire Ramp | | N/A | Ramp Length (in) | 56.0 | Yes | Ramp Slope (%) | 5.9 |
| 17/8 1: 200 C | | Remove & Replace | | | Yes | Ramp Width (in) | 97.5 | Yes | Ramp XSlope (%) | 0.6 |
| | | Total Cost: | \$ | 2600.00 | | Obstruction Type | | | Storm Grate/Utility Type | |
