Access Compliance Report

Public Rights-of-Way

(Curb Ramps)

Intersection ID: 14107	Main Street: RANLO_AV	Cross Street: S_TORRENCE_ST	Location: S
ADA ID: AB8E0FC64C2A	Ramp Type: PerpDiag	Initial Pass/Fail: Fail	Overall Compliance: No
Severity Score: 1.25			
Codes/Mitigation Info/Possible Solution		Field Measurements/Component Compliance

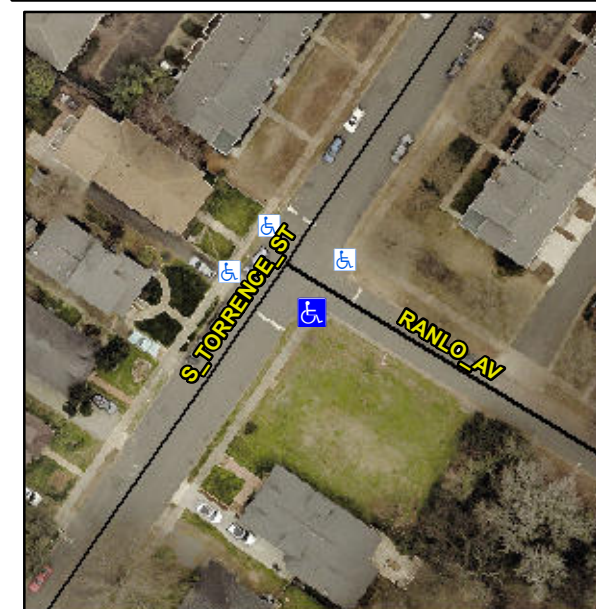
PROW/ADA:

Not Found, R304.5.3

Compliance	Description	Data	Compliance	Description	Data
N/A	Ramp Length (in)	47.0	Yes	Ramp Slope (%)	7.4
Yes	Ramp Width (in)	52.0	No	Ramp XSlope (%)	3.3
N/A	Flare Type LT	N/A	N/A	Flare Type RT	N/A
N/A	Flare Slope LT (%)	N/A	N/A	Flare Slope RT (%)	N/A
N/A	Flare Traversable LT?	N/A	N/A	Flare Traversable RT?	N/A
N/A	Landing Length (in)	N/A	N/A	DWS Provided?	N/A
N/A	Landing Width (in)	N/A	N/A	DWS Contrast?	N/A
N/A	Landing Slope (%)	N/A	N/A	DWS Length (in)	N/A
N/A	Landing X Slope (%)	N/A	N/A	DWS Full Width?	N/A
N/A	Landing Curb? (Y/N)	N/A	N/A	DWS Offset (in)	N/A
N/A	Shared Landing?	N/A			
N/A	Gutter Ponding?	N/A	N/A	Gutter Slope (%)	N/A
N/A	Gutter Lip Ht (in)	N/A	N/A	Gutter X Slope (%)	N/A
N/A	Painted X Walk1?	No	N/A	Painted X Walk2?	No
	X Walk 1 Direction	To NE		X Walk 2 Direction	To NW
N/A	X Walk 1 Width (in)	N/A	N/A	X Walk 2 Width (in)	N/A
	X Walk 1 Slope (%)	1.6		X Walk 2 Slope (%)	7.4
	X Walk 1 X Slope (%)	3.0		X Walk 2 X Slope (%)	1.0

N/A	Ramp inside XWalk1?	N/A	N/A	Ramp inside XWalk2?	N/A
	Road Slope (%)	4.7	N/A	Clear Space?	N/A
	Road X Slope (%)	1.1	N/A	Clear Space to XWalk (in)	N/A
N/A	Any Obstructions?	N/A	N/A	Storm Grate/Utility Hazard?	N/A
	Obstruction Type			Storm Grate/Utility Type	
		N/A			N/A
		Yes		Surface Condition? (G/P)	Good

Possible Solutions:

Remove & Replace Curb Ramp With Two New Directional Ramps or Equivalent.

Total Cost: \$ 3200.00
