# Access Compliance Report

### (Curb Ramps)

Intersection ID: 10023411	Main Street: CHOATE_CR	Cross Street: N/A	Location: E
ADA ID: AB958E925B98	Ramp Type: Combination2Diag	Initial Pass/Fail: Fail	Overall Compliance: No
		Severity Score: 0

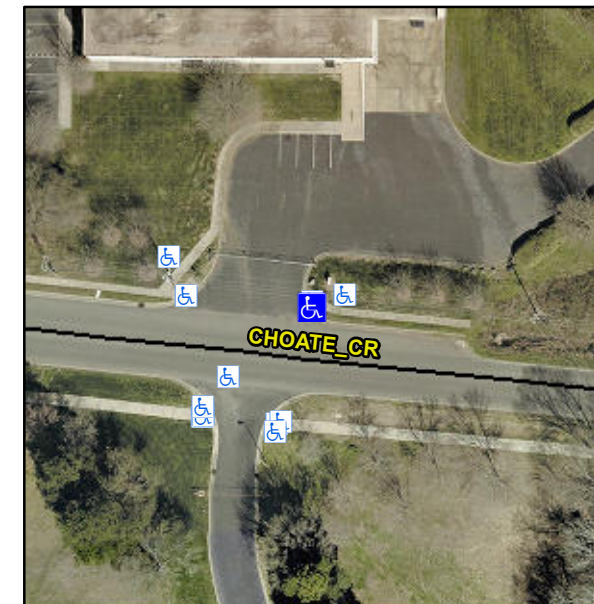
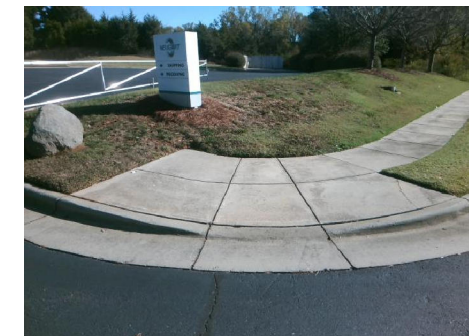
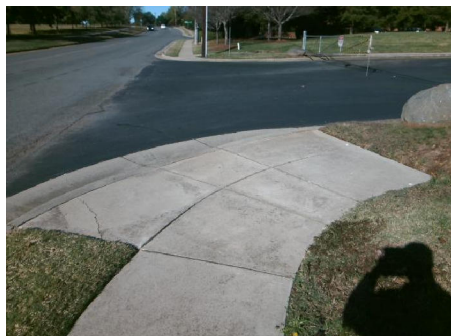
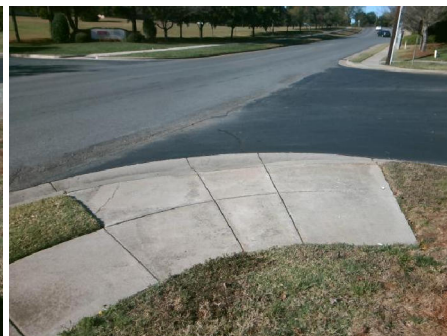
**Not Found, R304.5.1, R304.5.3, R304.3.2**

Compliance	Description	Data	Compliance	Description	Data
N/A	Ramp Length LT (in)	51.0	N/A	Ramp Length RT (in)	N/A
Yes	Ramp Width LT (in)	52.0	N/A	Ramp Width RT (in)	N/A
No	Ramp Slope LT (%)	10.7	N/A	Ramp Slope RT (%)	N/A
Yes	Ramp XSlope LT (%)	0.8	N/A	Ramp XSlope RT (%)	N/A
N/A	Ramp Length (in)	45.5	Yes	Ramp Slope (%)	5.1
No	Ramp Width (in)	35.0	No	Ramp XSlope (%)	5.6
N/A	Flare Type LT	N/A	N/A	Flare Type RT	N/A
N/A	Flare Slope LT (%)	N/A	N/A	Flare Slope RT (%)	N/A
N/A	Flare Traversable LT?	N/A	N/A	Flare Traversable RT?	N/A
N/A	Landing Length (in)	N/A	N/A	DWS Provided?	N/A
N/A	Landing Width (in)	N/A	N/A	DWS Contrast?	N/A
N/A	Landing Slope (%)	N/A	N/A	DWS Length (in)	N/A
N/A	Landing X Slope (%)	N/A	N/A	DWS Full Width?	N/A
N/A	Landing Curb? (Y/N)	N/A	N/A	DWS Offset (in)	N/A
N/A	Shared Landing?	N/A			
N/A	Gutter Ponding?	N/A	N/A	Gutter Slope (%)	N/A
N/A	Gutter Lip Ht (in)	N/A	N/A	Gutter X Slope (%)	N/A
N/A	Painted X Walk1?	No	N/A	Painted X Walk2?	No

**Remove & Replace Curb Ramp With Two New Directional Ramps or Equivalent.**
