# Access Compliance Report

## Public Rights-of-Way

### (Curb Ramps)

Intersection ID: 44458	Main Street: BUCKHORN_ST	Cross Street: KIRKVILLE_LN	Location: SE
ADA ID: AB9A1E06C7E6	Ramp Type: PerpDiag	Initial Pass/Fail: Fail	Overall Compliance: No
Severity Score: 30			
Codes/Mitigation Info/Possible Solution		Field Measurements/Component Compliance

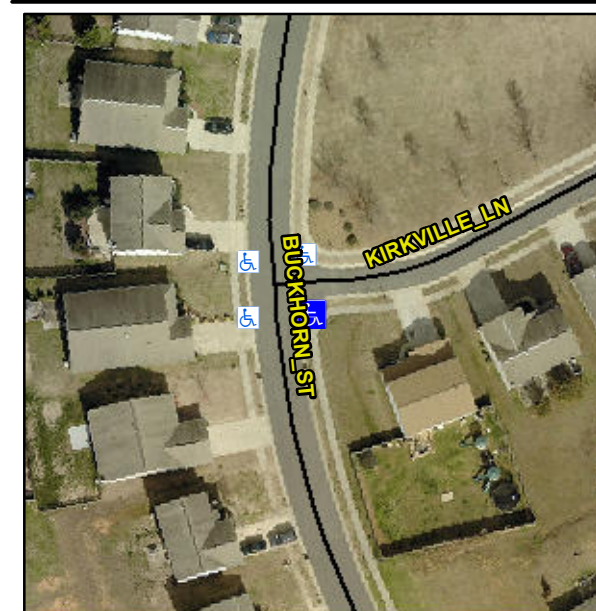
**Not Found, R304.5.1, R304.5.3**

Compliance	Description	Data	Compliance	Description	Data
N/A	Ramp Length (in)	48.0	Yes	Ramp Slope (%)	5.1
No	Ramp Width (in)	34.5	No	Ramp XSlope (%)	5.1
N/A	Flare Type LT	N/A	N/A	Flare Type RT	N/A
N/A	Flare Slope LT (%)	N/A	N/A	Flare Slope RT (%)	N/A
N/A	Flare Traversable LT?	N/A	N/A	Flare Traversable RT?	N/A
N/A	Landing Length (in)	N/A	N/A	DWS Provided?	N/A
N/A	Landing Width (in)	N/A	N/A	DWS Contrast?	N/A
N/A	Landing Slope (%)	N/A	N/A	DWS Length (in)	N/A
N/A	Landing X Slope (%)	N/A	N/A	DWS Full Width?	N/A
N/A	Landing Curb? (Y/N)	N/A	N/A	DWS Offset (in)	N/A
N/A	Shared Landing?	N/A			
N/A	Gutter Ponding?	N/A	N/A	Gutter Slope (%)	N/A
N/A	Gutter Lip Ht (in)	N/A	N/A	Gutter X Slope (%)	N/A
N/A	Painted X Walk1?	No	N/A	Painted X Walk2?	No
	X Walk 1 Direction	To N		X Walk 2 Direction	To W
N/A	X Walk 1 Width (in)	N/A	N/A	X Walk 2 Width (in)	N/A
	X Walk 1 Slope (%)	3.6		X Walk 2 Slope (%)	3.9
	X Walk 1 X Slope (%)	1.1		X Walk 2 X Slope (%)	2.2

N/A	Ramp inside XWalk1?	N/A	N/A	Ramp inside XWalk2?	N/A
	Road Slope (%)	4.1	N/A	Clear Space?	N/A
	Road X Slope (%)	1.0	N/A	Clear Space to XWalk (in)	N/A
N/A	Any Obstructions?	N/A	N/A	Storm Grate/Utility Hazard?	N/A
	Obstruction Type			Storm Grate/Utility Type	
		N/A			N/A
			Yes	Surface Condition? (G/P)	Good

**Remove & Replace Curb Ramp With Two New Directional Ramps or Equivalent.**
