# Access Compliance Report

## Public Rights-of-Way

### (Curb Ramps)

Intersection ID: N/A	Main Street: BROOKSVALE_ST	Cross Street: NOBLES_AV	Location: SE
ADA ID: AB9CB45C1250	Ramp Type: Perp	Initial Pass/Fail: Fail	Overall Compliance: No
Severity Score: 1.25			
Codes/Mitigation Info/Possible Solution		Field Measurements/Component Compliance

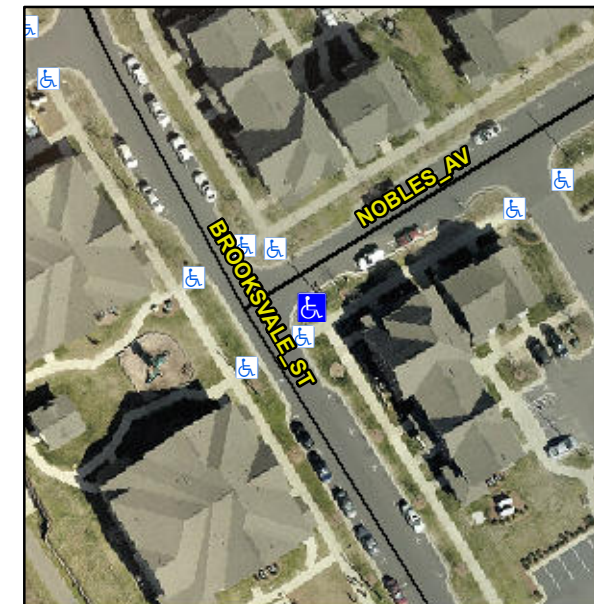
Compliance	Description	Data	Compliance	Description	Data
N/A	Ramp Length (in)	72.0	Yes	Ramp Slope (%)	5.9
Yes	Ramp Width (in)	71.0	No	Ramp XSlope (%)	2.6
N/A	Flare Type LT	N/A	N/A	Flare Type RT	N/A
N/A	Flare Slope LT (%)	N/A	N/A	Flare Slope RT (%)	N/A
N/A	Flare Traversable LT?	N/A	N/A	Flare Traversable RT?	N/A
N/A	Landing Length (in)	N/A	N/A	DWS Provided?	N/A
N/A	Landing Width (in)	N/A	N/A	DWS Contrast?	N/A
N/A	Landing Slope (%)	N/A	N/A	DWS Length (in)	N/A
N/A	Landing X Slope (%)	N/A	N/A	DWS Full Width?	N/A
N/A	Landing Curb? (Y/N)	N/A	N/A	DWS Offset (in)	N/A
N/A	Shared Landing?	N/A			
N/A	Gutter Ponding?	N/A	N/A	Gutter Slope (%)	N/A
N/A	Gutter Lip Ht (in)	N/A	N/A	Gutter X Slope (%)	N/A
N/A	Painted X Walk1?	No	N/A	Painted X Walk2?	N/A
	X Walk 1 Direction	To NW		X Walk 2 Direction	N/A
N/A	X Walk 1 Width (in)	N/A	N/A	X Walk 2 Width (in)	N/A
	X Walk 1 Slope (%)	1.5		X Walk 2 Slope (%)	N/A
	X Walk 1 X Slope (%)	1.1		X Walk 2 X Slope (%)	N/A

N/A	Ramp inside XWalk1?	N/A	N/A	Ramp inside XWalk2?	N/A
	Road Slope (%)	N/A	N/A	Clear Space?	N/A
	Road X Slope (%)	N/A	N/A	Clear Space to XWalk (in)	N/A
N/A	Any Obstructions?	N/A	N/A	Storm Grate/Utility Hazard?	N/A
	Obstruction Type			Storm Grate/Utility Type	
		N/A			N/A
		Yes		Surface Condition? (G/P)	Good

Possible Solutions:

**Remove & Replace Entire Ramp.**

**R304.5.3**
