# Access Compliance Report

## Public Rights-of-Way

### (Curb Ramps)

Intersection ID: 18778	Main Street: E_INDEPENDENCE_BV	Cross Street: E_W_T_HARRIS_BV	Location: SE
ADA ID: ABA057416B8F	Ramp Type: PerpDiag	Initial Pass/Fail: Fail	Overall Compliance: No
			Severity Score: 13.75

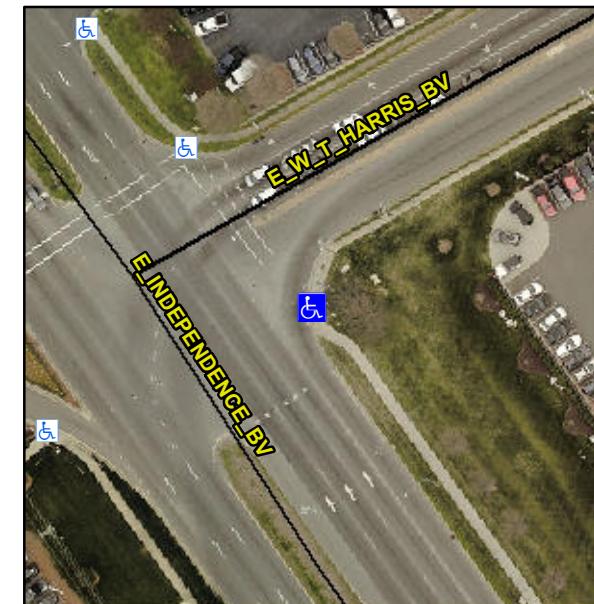
**Not Found, R304.2.2, R304.5.3**

Compliance	Description	Data	Compliance	Description	Data
N/A	Ramp Length (in)	72.0	No	Ramp Slope (%)	8.6
Yes	Ramp Width (in)	48.0	No	Ramp XSlope (%)	3.1
N/A	Flare Type LT	N/A	N/A	Flare Type RT	N/A
N/A	Flare Slope LT (%)	N/A	N/A	Flare Slope RT (%)	N/A
N/A	Flare Traversable LT?	N/A	N/A	Flare Traversable RT?	N/A
N/A	Landing Length (in)	N/A	N/A	DWS Provided?	N/A
N/A	Landing Width (in)	N/A	N/A	DWS Contrast?	N/A
N/A	Landing Slope (%)	N/A	N/A	DWS Length (in)	N/A
N/A	Landing X Slope (%)	N/A	N/A	DWS Full Width?	N/A
N/A	Landing Curb? (Y/N)	N/A	N/A	DWS Offset (in)	N/A
N/A	Shared Landing?	N/A			
N/A	Gutter Ponding?	N/A	N/A	Gutter Slope (%)	N/A
N/A	Gutter Lip Ht (in)	N/A	N/A	Gutter X Slope (%)	N/A
N/A	Painted X Walk1?	Yes	N/A	Painted X Walk2?	No
	X Walk 1 Direction	To N		X Walk 2 Direction	To W
N/A	X Walk 1 Width (in)	90.0	N/A	X Walk 2 Width (in)	N/A
	X Walk 1 Slope (%)	1.0		X Walk 2 Slope (%)	0.8
	X Walk 1 X Slope (%)	1.7		X Walk 2 X Slope (%)	1.6

N/A	Ramp inside XWalk1?	Yes	N/A	Ramp inside XWalk2?	N/A
	Road Slope (%)	1.4	N/A	Clear Space?	N/A
	Road X Slope (%)	0.2	N/A	Clear Space to XWalk (in)	N/A
N/A	Any Obstructions?	N/A	N/A	Storm Grate/Utility Hazard?	N/A
	Obstruction Type			Storm Grate/Utility Type	
		N/A			N/A
		Yes		Surface Condition? (G/P)	Good

**Remove & Replace Curb Ramp With Two New Directional Ramps or Equivalent.**
