Access Compliance Report

Public Rights-of-Way

(Curb Ramps)

Intersection ID: 14844	Main Street: DILWORTH_RD_WEST	Cross Street: EAST_BV	Location: E
ADA ID: ABA0F717B459	Ramp Type: Directional1	Initial Pass/Fail: Pass	Overall Compliance: No
Severity Score: 5			
Codes/Mitigation Info/Possible Solution		Field Measurements/Component Compliance

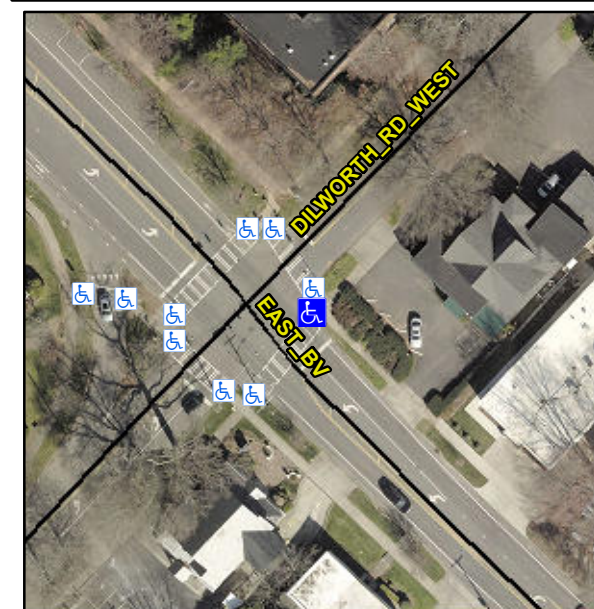
Not Found, R304.5.2, R304.5.4

Compliance	Description	Data	Compliance	Description	Data
N/A	Ramp Length (in)	76.0	No	Grade Break?	No
Yes	Ramp Width (in)	62.0	N/A	Grade Break Slope (%)	9.6
Yes	Ramp Slope (%)	7.1	N/A	Grade Break XSlope (%)	1.8
Yes	Ramp XSlope (%)	1.6			
Yes	Flare Type LT	N/A	N/A	Flare Type RT	N/A
N/A	Flare Slope LT (%)	N/A	N/A	Flare Slope RT (%)	N/A
N/A	Flare Traversable LT?	No	N/A	Flare Traversable RT?	N/A
Yes	Landing Length (in)	69.0	Yes	DWS Provided?	Yes
Yes	Landing Width (in)	60.0	Yes	DWS Contrast?	Yes
Yes	Landing Slope (%)	0.3	Yes	DWS Length (in)	25.0
Yes	Landing X Slope (%)	0.0	Yes	DWS Full Width?	Yes
N/A	Landing Curb? (Y/N)	N/A	Yes	DWS Offset LT (in)	1.0
N/A	Shared Landing?	Yes	Yes	DWS Offset RT (in)	11.0
Yes	Gutter Ponding?	No	No	Gutter Slope (%)	6.5
Yes	Gutter Lip Ht (in)	0.0	Yes	Gutter X Slope (%)	1.0
N/A	Painted X Walk1?	Yes		Road Slope (%)	6.1
	X Walk 1 Direction	To SW		Road X Slope (%)	2.2
	X Walk 1 Width (in)	116.0		Clear Space?	Yes

X Walk 1 Slope (%)	6.1	N/A	Clear Space to XWalk (in)	N/A
	X Walk 1 X Slope (%)	2.2	Yes	Storm Grate/Utility Hazard?	No
Yes	Ramp inside XWalk1?	Yes		Storm Grate/Utility Type	
Yes	Any Obstructions?	No			N/A
	Obstruction Type		Yes	Surface Condition? (G/P)	Good
			N/A	Curb Slope (%)	15.5

**Remove & Replace Entire Ramp.
Remove & Replace Gutter.**
