Access Compliance Report

Public Rights-of-Way (Curb Ramps)

Intersection ID: 24993	Main Street: TRESANTON_DR	Cross Street: TYNE_CT	Location:	E
ADA ID: ABADB3C70560	Ramp Type: PerpDiag	Initial Pass/Fail: Fail	Overall Compliance: No	Severity Score: 12.5
Codes/Mitigation Info/Possible Solution		Field Measurements/Component Compliance

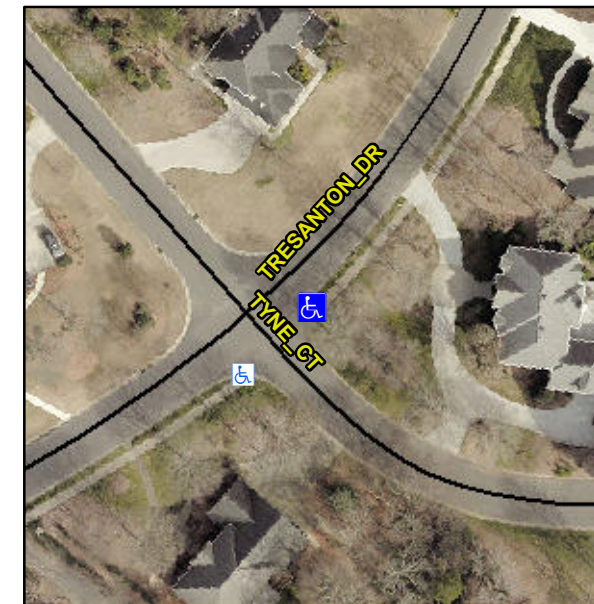
Not Found, R304.2.2

Compliance	Description	Data	Compliance	Description	Data
N/A	Ramp Length (in)	48.0	No	Ramp Slope (%)	11.3
Yes	Ramp Width (in)	48.0	Yes	Ramp XSlope (%)	1.6
N/A	Flare Type LT	N/A	N/A	Flare Type RT	N/A
N/A	Flare Slope LT (%)	N/A	N/A	Flare Slope RT (%)	N/A
N/A	Flare Traversable LT?	N/A	N/A	Flare Traversable RT?	N/A
N/A	Landing Length (in)	N/A	N/A	DWS Provided?	N/A
N/A	Landing Width (in)	N/A	N/A	DWS Contrast?	N/A
N/A	Landing Slope (%)	N/A	N/A	DWS Length (in)	N/A
N/A	Landing X Slope (%)	N/A	N/A	DWS Full Width?	N/A
N/A	Landing Curb? (Y/N)	N/A	N/A	DWS Offset (in)	N/A
N/A	Shared Landing?	N/A			
N/A	Gutter Ponding?	N/A	N/A	Gutter Slope (%)	N/A
N/A	Gutter Lip Ht (in)	N/A	N/A	Gutter X Slope (%)	N/A
N/A	Painted X Walk1?	No	N/A	Painted X Walk2?	No
	X Walk 1 Direction	To NW		X Walk 2 Direction	To SW
N/A	X Walk 1 Width (in)	N/A	N/A	X Walk 2 Width (in)	N/A
	X Walk 1 Slope (%)	3.9		X Walk 2 Slope (%)	1.3
	X Walk 1 X Slope (%)	1.0		X Walk 2 X Slope (%)	4.0

N/A	Ramp inside XWalk1?	N/A	N/A	Ramp inside XWalk2?	N/A
	Road Slope (%)	0.4	N/A	Clear Space?	N/A
	Road X Slope (%)	3.0	N/A	Clear Space to XWalk (in)	N/A
N/A	Any Obstructions?	N/A	N/A	Storm Grate/Utility Hazard?	N/A
	Obstruction Type			Storm Grate/Utility Type	
		N/A			N/A
			Yes	Surface Condition? (G/P)	Good

Possible Solutions:

Remove & Replace Curb Ramp With Two New Directional Ramps or Equivalent.
