Access Compliance Report Public Rights-of-Way (Curb Ramps)

Intersection ID: 13071Main Street:N_SHARON_AMITY_RDCross Street: VERNEDALE_RDLocation:NADA ID: ABB800056CBERamp Type:PerpInitial Pass/Fail:FailOverall Compliance: NoSeverity Score:22.5

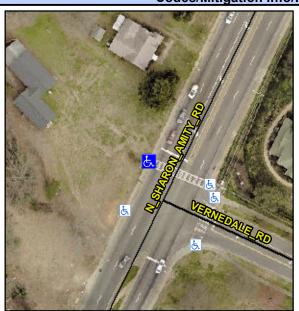
Field Measurements/Component Compliance							
Compliance Description		Data	Comp	oliance Description	Data		
N/A	Ramp Length (in)	60.0	No	Ramp Slope (%)	11.3		
No	Ramp Width (in)	40.0	No	Ramp XSlope (%)	4.5		
N/A	Flare Type LT	N/A	N/A	Flare Type RT	N/A		
N/A	Flare Slope LT (%)	N/A	N/A	Flare Slope RT (%)	N/A		
N/A	Flare Traversable LT?	N/A	N/A	Flare Traversable RT?	N/A		
N/A	Landing Length (in)	N/A	N/A	DWS Provided?	N/A		
N/A	Landing Width (in)	N/A	N/A	DWS Contrast?	N/A		
N/A	Landing Slope (%)	N/A	N/A	DWS Length (in)	N/A		
N/A	Landing X Slope (%)	N/A	N/A	DWS Full Width?	N/A		
N/A	Landing Curb? (Y/N)	N/A	N/A	DWS Offset (in)	N/A		
N/A	Shared Landing?	N/A					
N/A	Gutter Ponding?	N/A	N/A	Gutter Slope (%)	N/A		
N/A	Gutter Lip Ht (in)	N/A	N/A	Gutter X Slope (%)	N/A		
N/A	Painted X Walk1?	Yes	N/A	Painted X Walk2?	N/A		
	X Walk 1 Direction	To SE		X Walk 2 Direction	N/A		
N/A	X Walk 1 Width (in)	87.0	N/A	X Walk 2 Width (in)	N/A

X Walk 1 Slope (%)	3.0		X Walk 2 Slope (%)	N/A		
	X Walk 1 X Slope (%)	1.0		X Walk 2 X Slope (%)	N/A		
N/A	Ramp inside XWalk1?	Yes	N/A	Ramp inside XWalk2?	N/A		
	Road Slope (%)	N/A	N/A	Clear Space?	N/A		
	Road X Slope (%)	N/A	N/A	Clear Space to XWalk (in)	N/A		
N/A	Any Obstructions?	N/A	N/A	Storm Grate/Utility Hazard?	N/A		
	Obstruction Type			Storm Grate/Utility Type			
		N/A			N/A		
			Yes	Surface Condition? (G/P)	Good

Possible Solutions:				
Remove & Replace Entire Ramp.				
	ı			
	1			
	ı			
	ı			
Surveyor Notes:				
N/A				
PROW/ADA:				
Not Found, R304.5.1, R304.2.2,				
R304.5.3	i			
	ı

Total Cost: \$ 1850.00
