Access Compliance Report

Public Rights-of-Way

(Curb Ramps)

Intersection ID: N/A	Main Street: GLENBURN_LN	Cross Street: DULNIAN_WY	Location: NW
ADA ID: ABB90954B5D9	Ramp Type: PerpDiag	Initial Pass/Fail: Fail	Overall Compliance: No
		Severity Score: 10

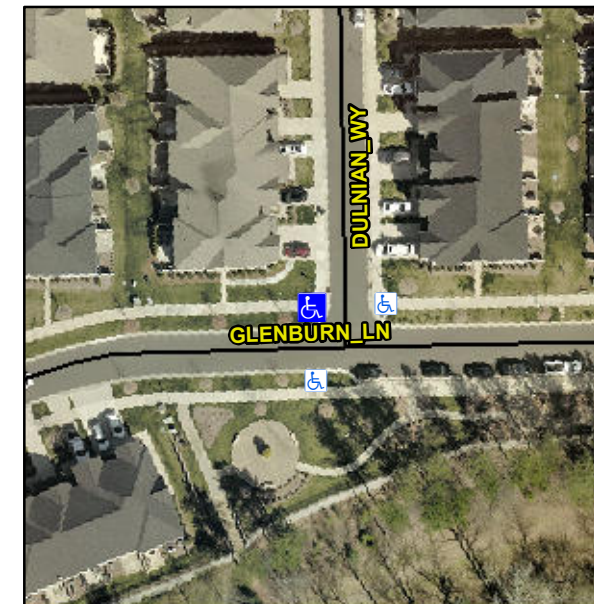
Not Found, R304.5.1, R304.5.3

Compliance	Description	Data	Compliance	Description	Data
N/A	Ramp Length (in)	81.0	Yes	Ramp Slope (%)	5.3
No	Ramp Width (in)	47.0	No	Ramp XSlope (%)	2.2
N/A	Flare Type LT	N/A	N/A	Flare Type RT	N/A
N/A	Flare Slope LT (%)	N/A	N/A	Flare Slope RT (%)	N/A
N/A	Flare Traversable LT?	N/A	N/A	Flare Traversable RT?	N/A
N/A	Landing Length (in)	N/A	N/A	DWS Provided?	N/A
N/A	Landing Width (in)	N/A	N/A	DWS Contrast?	N/A
N/A	Landing Slope (%)	N/A	N/A	DWS Length (in)	N/A
N/A	Landing X Slope (%)	N/A	N/A	DWS Full Width?	N/A
N/A	Landing Curb? (Y/N)	N/A	N/A	DWS Offset (in)	N/A
N/A	Shared Landing?	N/A			
N/A	Gutter Ponding?	N/A	N/A	Gutter Slope (%)	N/A
N/A	Gutter Lip Ht (in)	N/A	N/A	Gutter X Slope (%)	N/A
N/A	Painted X Walk1?	No	N/A	Painted X Walk2?	No
	X Walk 1 Direction	To S		X Walk 2 Direction	To E
N/A	X Walk 1 Width (in)	N/A	N/A	X Walk 2 Width (in)	N/A
	X Walk 1 Slope (%)	2.2		X Walk 2 Slope (%)	2.1
	X Walk 1 X Slope (%)	0.7		X Walk 2 X Slope (%)	0.9

N/A	Ramp inside XWalk1?	N/A	N/A	Ramp inside XWalk2?	N/A
	Road Slope (%)	1.3	N/A	Clear Space?	N/A
	Road X Slope (%)	3.3	N/A	Clear Space to XWalk (in)	N/A
N/A	Any Obstructions?	N/A	N/A	Storm Grate/Utility Hazard?	N/A
	Obstruction Type			Storm Grate/Utility Type	
		N/A			N/A
		Yes		Surface Condition? (G/P)	Good

Remove & Replace Curb Ramp With Two New Directional Ramps or Equivalent.

Total Cost: \$ 3200.00
