# Access Compliance Report

## Public Rights-of-Way

### (Curb Ramps)

| Intersection ID: 30017 | Main Street: GREENBANK_CT | Cross Street: OLD_CAROLINA_DR | Location: S |

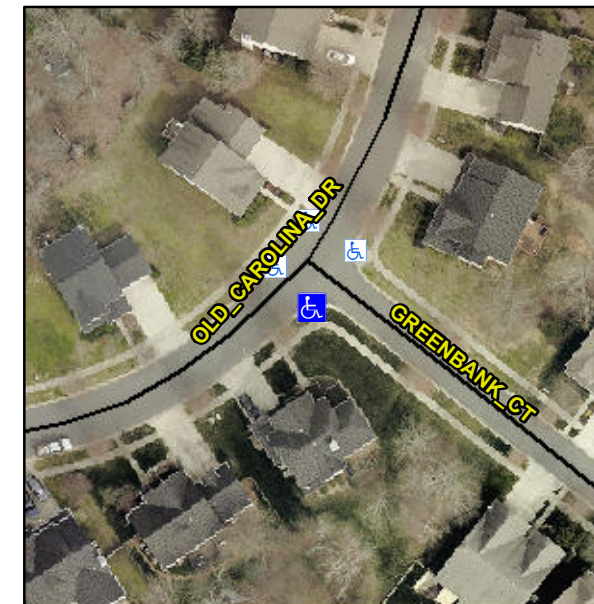
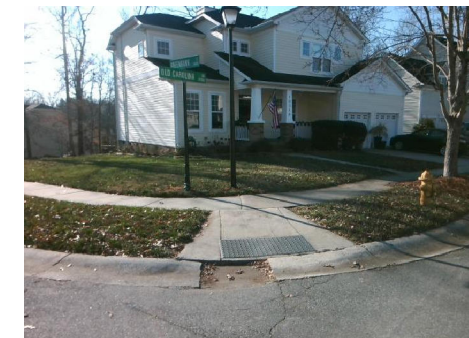
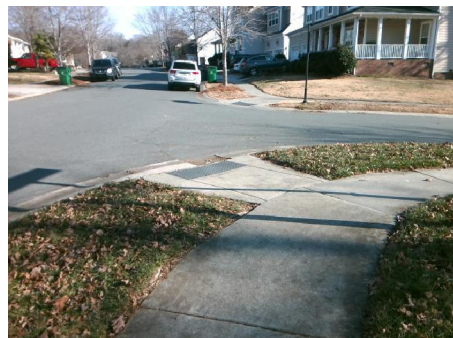
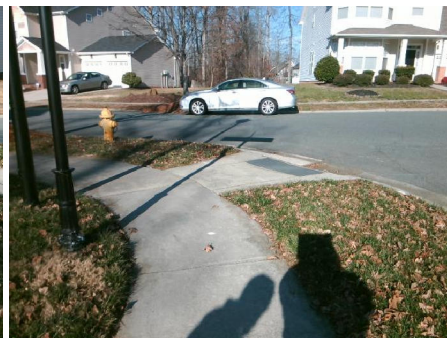
| ADA ID: ABC5AAFA270F | Ramp Type: PerpDiag | Initial Pass/Fail: Fail | Overall Compliance: No |
| Severity Score: 25 | | | |

**Not Found, R304.5.1, R304.5.3, R302.7**

| Compliance | Description | Data | Compliance | Description | Data |
|---|---|---|---|---|---|
| N/A | Ramp Length (in) | 83.0 | Yes | Ramp Slope (%) | 6.2 |
| No | Ramp Width (in) | 42.5 | No | Ramp XSlope (%) | 2.7 |
| | | No | | Surface Condition? (G/P) | Poor |

**Remove & Replace Curb Ramp With Two New Directional Ramps or Equivalent.**

Total Cost: \$ 3200.00
