Access Compliance Report

Public Rights-of-Way

(Curb Ramps)

Intersection ID: N/A	Main Street: E 8TH ST	Cross Street: N BREVARD ST	Location: W
ADA ID: ABC67F547B0C	Ramp Type: Perp	Initial Pass/Fail: Fail	Overall Compliance: No
Severity Score: 21.25			
Codes/Mitigation Info/Possible Solution		Field Measurements/Component Compliance

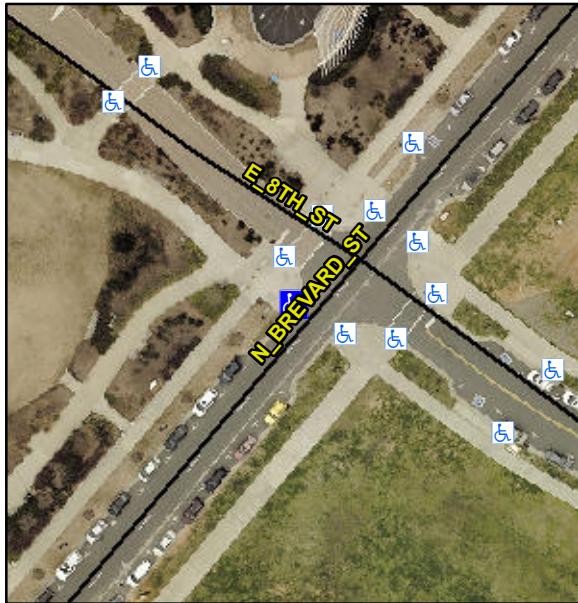
Not Found, R304.5.1, R304.2.2

Compliance	Description	Data	Compliance	Description	Data
N/A	Ramp Length (in)	71.0	No	Ramp Slope (%)	8.5
No	Ramp Width (in)	45.0	Yes	Ramp XSlope (%)	1.5
N/A	Flare Type LT	N/A	N/A	Flare Type RT	N/A
N/A	Flare Slope LT (%)	N/A	N/A	Flare Slope RT (%)	N/A
N/A	Flare Traversable LT?	No	N/A	Flare Traversable RT?	No
N/A	Landing Length (in)	N/A	N/A	DWS Provided?	N/A
N/A	Landing Width (in)	N/A	N/A	DWS Contrast?	N/A
N/A	Landing Slope (%)	N/A	N/A	DWS Length (in)	N/A
N/A	Landing X Slope (%)	N/A	N/A	DWS Full Width?	N/A
N/A	Landing Curb? (Y/N)	N/A	N/A	DWS Offset (in)	N/A
N/A	Shared Landing?	N/A			
N/A	Gutter Ponding?	N/A	N/A	Gutter Slope (%)	N/A
N/A	Gutter Lip Ht (in)	N/A	N/A	Gutter X Slope (%)	N/A
N/A	Painted X Walk1?	No	N/A	Painted X Walk2?	N/A
	X Walk 1 Direction	To SE		X Walk 2 Direction	N/A
N/A	X Walk 1 Width (in)	N/A	N/A	X Walk 2 Width (in)	N/A
	X Walk 1 Slope (%)	1.4		X Walk 2 Slope (%)	N/A
	X Walk 1 X Slope (%)	0.2		X Walk 2 X Slope (%)	N/A

N/A	Ramp inside XWalk1?	N/A	N/A	Ramp inside XWalk2?	N/A
	Road Slope (%)	N/A	N/A	Clear Space?	N/A
	Road X Slope (%)	N/A	N/A	Clear Space to XWalk (in)	N/A
N/A	Any Obstructions?	N/A	N/A	Storm Grate/Utility Hazard?	N/A
	Obstruction Type			Storm Grate/Utility Type	
		N/A			N/A
		Yes		Surface Condition? (G/P)	Good

Remove & Replace Entire Ramp.
