# Access Compliance Report

## Public Rights-of-Way (Curb Ramps)

Intersection ID: 26728	Main Street: ARBORHILL_RD	Cross Street: BEACON_FOREST_DR	Location: SW
ADA ID: ABD88F943EFE	Ramp Type: Perp	Initial Pass/Fail: Fail	Overall Compliance: No
Severity Score: 8.75			
Codes/Mitigation Info/Possible Solution		Field Measurements/Component Compliance

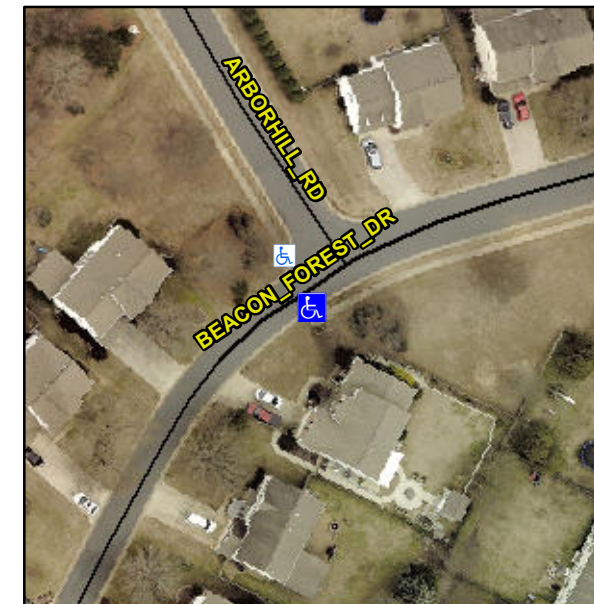
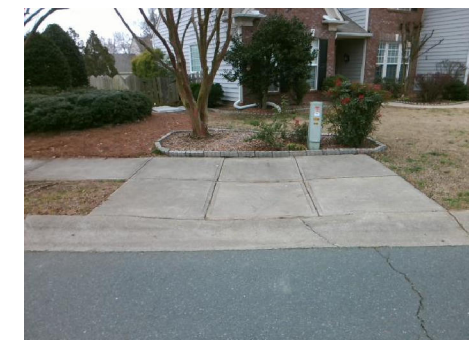
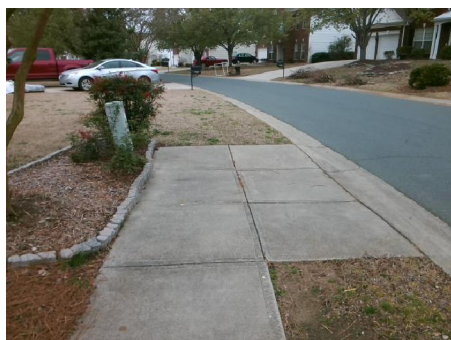
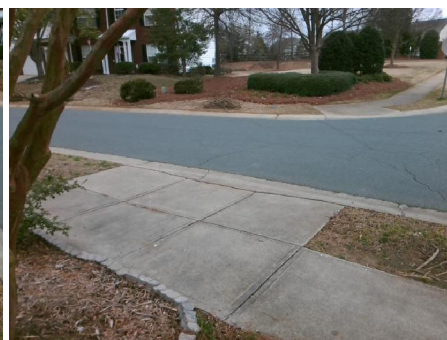
**Not Found, R304.5.1**

Compliance	Description	Data	Compliance	Description	Data
N/A	Ramp Length (in)	96.0	Yes	Ramp Slope (%)	6.2
No	Ramp Width (in)	44.0	Yes	Ramp XSlope (%)	0.3
N/A	Flare Type LT	N/A	N/A	Flare Type RT	N/A
N/A	Flare Slope LT (%)	N/A	N/A	Flare Slope RT (%)	N/A
N/A	Flare Traversable LT?	N/A	N/A	Flare Traversable RT?	N/A
N/A	Landing Length (in)	N/A	N/A	DWS Provided?	N/A
N/A	Landing Width (in)	N/A	N/A	DWS Contrast?	N/A
N/A	Landing Slope (%)	N/A	N/A	DWS Length (in)	N/A
N/A	Landing X Slope (%)	N/A	N/A	DWS Full Width?	N/A
N/A	Landing Curb? (Y/N)	N/A	N/A	DWS Offset (in)	N/A
N/A	Shared Landing?	N/A			
N/A	Gutter Ponding?	N/A	N/A	Gutter Slope (%)	N/A
N/A	Gutter Lip Ht (in)	N/A	N/A	Gutter X Slope (%)	N/A
N/A	Painted X Walk1?	No	N/A	Painted X Walk2?	N/A
	X Walk 1 Direction	To N		X Walk 2 Direction	N/A
N/A	X Walk 1 Width (in)	N/A	N/A	X Walk 2 Width (in)	N/A
	X Walk 1 Slope (%)	3.3		X Walk 2 Slope (%)	N/A
	X Walk 1 X Slope (%)	1.2		X Walk 2 X Slope (%)	N/A

N/A	Ramp inside XWalk1?	N/A	N/A	Ramp inside XWalk2?	N/A
	Road Slope (%)	N/A	N/A	Clear Space?	N/A
	Road X Slope (%)	N/A	N/A	Clear Space to XWalk (in)	N/A
N/A	Any Obstructions?	N/A	N/A	Storm Grate/Utility Hazard?	N/A
	Obstruction Type			Storm Grate/Utility Type	
		N/A			N/A
			Yes	Surface Condition? (G/P)	Good

**Remove & Replace Entire Ramp.**

Total Cost: \$ 1850.00
