Access Compliance Report

Public Rights-of-Way

(Curb Ramps)

Intersection ID: 28118	Main Street: DARBY_CHASE_DR	Cross Street: KENSWORTH_CT	Location: SW
ADA ID: ABDEFBA5AA4E	Ramp Type: Perp	Initial Pass/Fail: Fail	Overall Compliance: No
Severity Score: 50			
Codes/Mitigation Info/Possible Solution		Field Measurements/Component Compliance

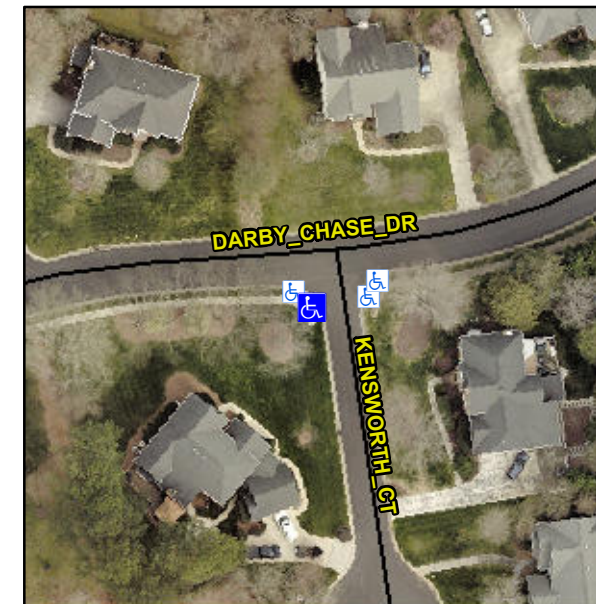
PROW/ADA:

Not Found, R304.5.1, R302.7

Compliance	Description	Data	Compliance	Description	Data
N/A	Ramp Length (in)	44.5	Yes	Ramp Slope (%)	7.6
No	Ramp Width (in)	25.0	Yes	Ramp XSlope (%)	0.0
N/A	Flare Type LT	N/A	N/A	Flare Type RT	N/A
N/A	Flare Slope LT (%)	N/A	N/A	Flare Slope RT (%)	N/A
N/A	Flare Traversable LT?	N/A	N/A	Flare Traversable RT?	N/A
N/A	Landing Length (in)	N/A	N/A	DWS Provided?	N/A
N/A	Landing Width (in)	N/A	N/A	DWS Contrast?	N/A
N/A	Landing Slope (%)	N/A	N/A	DWS Length (in)	N/A
N/A	Landing X Slope (%)	N/A	N/A	DWS Full Width?	N/A
N/A	Landing Curb? (Y/N)	N/A	N/A	DWS Offset (in)	N/A
N/A	Shared Landing?	N/A			
N/A	Gutter Ponding?	N/A	N/A	Gutter Slope (%)	N/A
N/A	Gutter Lip Ht (in)	N/A	N/A	Gutter X Slope (%)	N/A
N/A	Painted X Walk1?	No	N/A	Painted X Walk2?	N/A
	X Walk 1 Direction	To E		X Walk 2 Direction	N/A
N/A	X Walk 1 Width (in)	N/A	N/A	X Walk 2 Width (in)	N/A
	X Walk 1 Slope (%)	2.9		X Walk 2 Slope (%)	N/A
	X Walk 1 X Slope (%)	1.6		X Walk 2 X Slope (%)	N/A

N/A	Ramp inside XWalk1?	N/A	N/A	Ramp inside XWalk2?	N/A
	Road Slope (%)	N/A	N/A	Clear Space?	N/A
	Road X Slope (%)	N/A	N/A	Clear Space to XWalk (in)	N/A
N/A	Any Obstructions?	N/A	N/A	Storm Grate/Utility Hazard?	N/A
	Obstruction Type			Storm Grate/Utility Type	
		N/A			N/A
		No		Surface Condition? (G/P)	Poor

Possible Solutions:

Remove & Replace Entire Ramp.

Total Cost: \$ 1850.00
