## **Access Compliance Report Public Rights-of-Way** (Curb Ramps)

Intersection ID: 13482 Main Street: ARNOLD DR Cross Street: CENTRAL\_AV Location: NW **Overall Compliance: No** ADA ID: ABE3E3B9AC15 Ramp Type: Perp Initial Pass/Fail: Fail **Severity Score:** 10

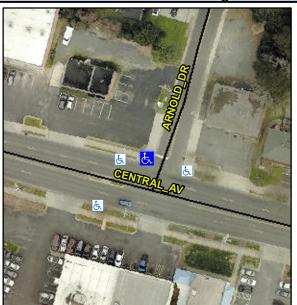
Field Measurements/Component Compliance		
Compliance Description Data Com	pliance Description	Data
N/A Ramp Length (in) 25.0 Yes	Ramp Slope (%)	7.7
No Ramp Width (in) 47.0 No	Ramp XSlope (%)	3.8
N/A Flare Type LT N/A N/A	Flare Type RT	N/A
N/A Flare Slope LT (%) N/A N/A	Flare Slope RT (%)	N/A
N/A Flare Traversable LT? N/A N/A	Flare Traversable RT?	N/A
N/A Landing Length (in) N/A N/A	DWS Provided?	N/A
N/A Landing Width (in) N/A N/A	DWS Contrast?	N/A
N/A Landing Slope (%) N/A N/A	DWS Length (in)	N/A
N/A Landing X Slope (%) N/A N/A	DWS Full Width?	N/A
N/A Landing Curb? (Y/N) N/A N/A	DWS Offset (in)	N/A
N/A Shared Landing? N/A		
N/A Gutter Ponding? N/A N/A	Gutter Slope (%)	N/A
N/A Gutter Lip Ht (in) N/A N/A	Gutter X Slope (%)	N/A
N/A Painted X Walk1? No N/A	Painted X Walk2?	N/A
X Walk 1 Direction To SE	X Walk 2 Direction	N/A
N/A X Walk 1 Width (in) N/A N/A	X Walk 2 Width (in)	N/A
X Walk 1 Slope (%) <b>6.0</b>	X Walk 2 Slope (%)	N/A

X Walk 1 X Slope (%) 2.5	X Walk 2 X Slope (%)	N/A
N/A Ramp inside XWalk1? N/A N/A	Ramp inside XWalk2?	N/A
Road Slope (%) N/A N/A	Clear Space?	N/A
Road X Slope (%) N/A N/A	Clear Space to XWalk (in)	N/A
N/A Any Obstructions? N/A N/A	Storm Grate/Utility Hazard?	N/A
Obstruction Type	Storm Grate/Utility Type	
N/A		N/A
Yes	Surface Condition? (G/P)	Good

Street 1 Name ARNOLD DR Stop Condition-Street 2 StopSign Street 2 Name N/A Stop Condition-Street 1 N/A Possible Solutions: Remove & Replace Entire Ramp. Surveyor Notes: N/A PROW/ADA: Not Found, R304.5.1, R304.5.3
