Access Compliance Report

Public Rights-of-Way

(Curb Ramps)

Intersection ID: 10025367	Main Street: E_8TH_ST	Cross Street: N/A	Location: E
ADA ID: ABE542F9B461	Ramp Type: Perp	Initial Pass/Fail: Fail	Overall Compliance: No
Severity Score: 13.75			
Codes/Mitigation Info/Possible Solution		Field Measurements/Component Compliance

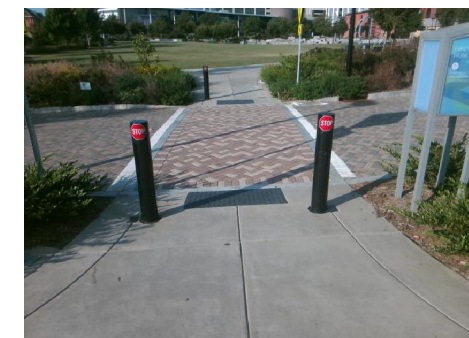
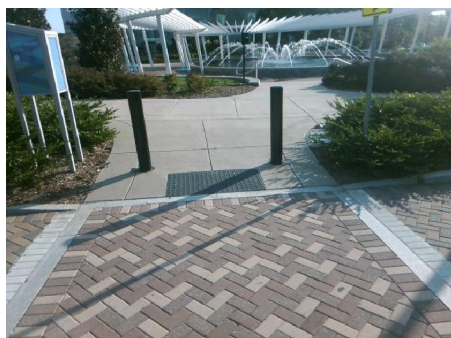
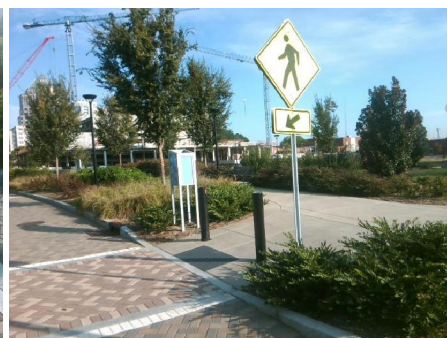
Compliance	Description	Data	Compliance	Description	Data
N/A	Ramp Length (in)	128.0	No	Ramp Slope (%)	9.0
Yes	Ramp Width (in)	60.0	No	Ramp XSlope (%)	4.1
N/A	Flare Type LT	N/A	N/A	Flare Type RT	N/A
N/A	Flare Slope LT (%)	N/A	N/A	Flare Slope RT (%)	N/A
N/A	Flare Traversable LT?	N/A	N/A	Flare Traversable RT?	N/A
N/A	Landing Length (in)	N/A	N/A	DWS Provided?	N/A
N/A	Landing Width (in)	N/A	N/A	DWS Contrast?	N/A
N/A	Landing Slope (%)	N/A	N/A	DWS Length (in)	N/A
N/A	Landing X Slope (%)	N/A	N/A	DWS Full Width?	N/A
N/A	Landing Curb? (Y/N)	N/A	N/A	DWS Offset (in)	N/A
N/A	Shared Landing?	N/A			
N/A	Gutter Ponding?	N/A	N/A	Gutter Slope (%)	N/A
N/A	Gutter Lip Ht (in)	N/A	N/A	Gutter X Slope (%)	N/A
N/A	Painted X Walk1?	Yes	N/A	Painted X Walk2?	N/A
	X Walk 1 Direction	To SW		X Walk 2 Direction	N/A
N/A	X Walk 1 Width (in)	120.0	N/A	X Walk 2 Width (in)	N/A
	X Walk 1 Slope (%)	1.0		X Walk 2 Slope (%)	N/A
	X Walk 1 X Slope (%)	2.1		X Walk 2 X Slope (%)	N/A

N/A	Ramp inside XWalk1?	Yes	N/A	Ramp inside XWalk2?	N/A
	Road Slope (%)	N/A	N/A	Clear Space?	N/A
	Road X Slope (%)	N/A	N/A	Clear Space to XWalk (in)	N/A
N/A	Any Obstructions?	N/A	N/A	Storm Grate/Utility Hazard?	N/A
	Obstruction Type			Storm Grate/Utility Type	
		N/A			N/A
		Yes		Surface Condition? (G/P)	Good

Possible Solutions:

Remove & Replace Entire Ramp.
