# Access Compliance Report

## Public Rights-of-Way

| Intersection ID: 45775 | Main Street: BITTER_CREEK_DR | Cross Street: CARVER_FALLS_RD | Location: | N |
| ADA ID: ABF42007CCBB | Ramp Type: PerpDiag | Initial Pass/Fail: Fail | Overall Compliance: No | Severity Score: 10 |

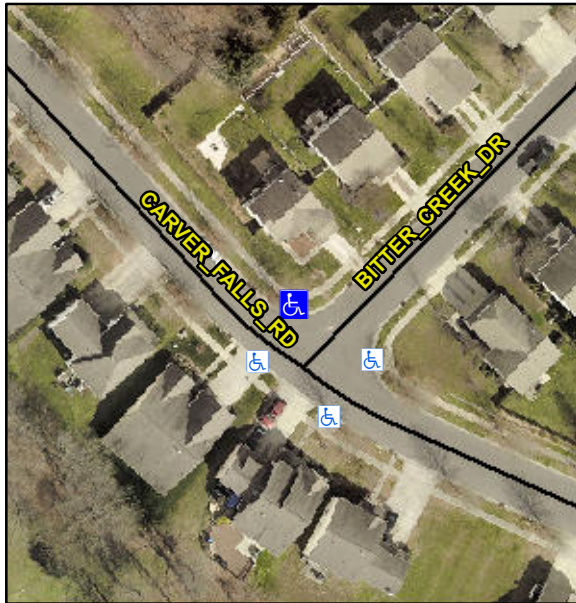
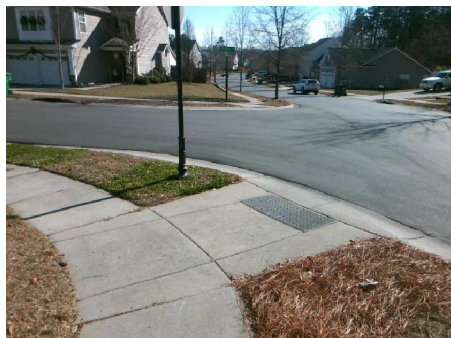
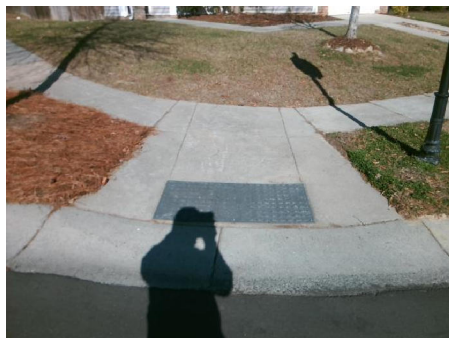
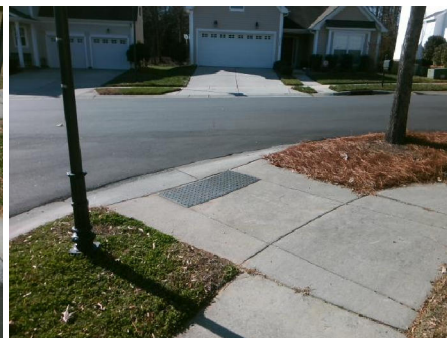
**R304.5.1, R304.5.3**

| Compliance | Description | Data | Compliance | Description | Data |
|---|---|---|---|---|---|
| N/A | Ramp Length (in) | 73.0 | Yes | Ramp Slope (%) | 5.0 |
| No | Ramp Width (in) | 47.5 | No | Ramp XSlope (%) | 4.0 |

**Remove & Replace Curb Ramp With Two New Directional Ramps or Equivalent.**
