Access Compliance Report

Public Rights-of-Way

(Curb Ramps)

Intersection ID: 10559	Main Street: CHARLES_AV	Cross Street: E_35TH_ST	Location: N
ADA ID: ABF4D923B94E	Ramp Type: PerpDiag	Initial Pass/Fail: Fail	Overall Compliance: No
		Severity Score: 10

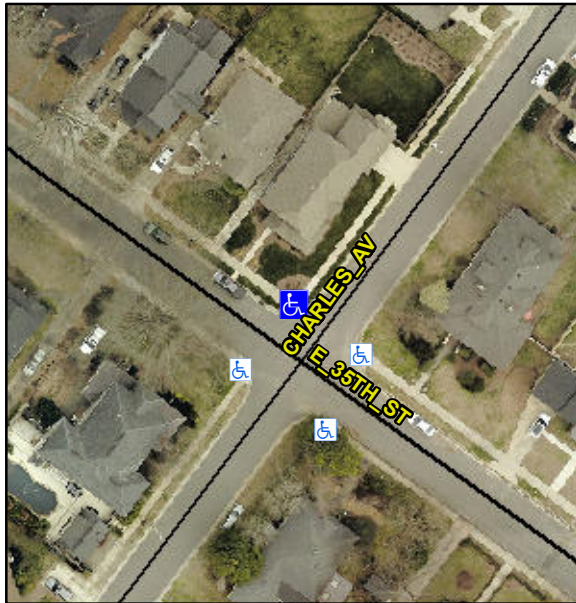
Not Found, R304.5.1, R304.5.3

Compliance	Description	Data	Compliance	Description	Data
N/A	Ramp Length (in)	68.0	Yes	Ramp Slope (%)	5.2
No	Ramp Width (in)	44.0	No	Ramp XSlope (%)	2.2
N/A	Flare Type LT	N/A	N/A	Flare Type RT	N/A
N/A	Flare Slope LT (%)	N/A	N/A	Flare Slope RT (%)	N/A
N/A	Flare Traversable LT?	N/A	N/A	Flare Traversable RT?	N/A
N/A	Landing Length (in)	N/A	N/A	DWS Provided?	N/A
N/A	Landing Width (in)	N/A	N/A	DWS Contrast?	N/A
N/A	Landing Slope (%)	N/A	N/A	DWS Length (in)	N/A
N/A	Landing X Slope (%)	N/A	N/A	DWS Full Width?	N/A
N/A	Landing Curb? (Y/N)	N/A	N/A	DWS Offset (in)	N/A
N/A	Shared Landing?	N/A			
N/A	Gutter Ponding?	N/A	N/A	Gutter Slope (%)	N/A
N/A	Gutter Lip Ht (in)	N/A	N/A	Gutter X Slope (%)	N/A
N/A	Painted X Walk1?	No	N/A	Painted X Walk2?	No
	X Walk 1 Direction	To SW		X Walk 2 Direction	To SE
N/A	X Walk 1 Width (in)	N/A	N/A	X Walk 2 Width (in)	N/A
	X Walk 1 Slope (%)	1.7		X Walk 2 Slope (%)	0.3
	X Walk 1 X Slope (%)	1.7		X Walk 2 X Slope (%)	1.3

N/A	Ramp inside XWalk1?	N/A	N/A	Ramp inside XWalk2?	N/A
	Road Slope (%)	2.1	N/A	Clear Space?	N/A
	Road X Slope (%)	2.6	N/A	Clear Space to XWalk (in)	N/A
N/A	Any Obstructions?	N/A	N/A	Storm Grate/Utility Hazard?	N/A
	Obstruction Type			Storm Grate/Utility Type	
		N/A			N/A
			Yes	Surface Condition? (G/P)	Good

Remove & Replace Curb Ramp With Two New Directional Ramps or Equivalent.
