Access Compliance Report

Public Rights-of-Way

(Curb Ramps)

Intersection ID: 47843		Main Street: ALVARADO_WY		Cross Street: DEL_RIO_RD		Location: SE			
ADA ID: ABF9A97AAB98		Ramp Type: PerpDiag		Initial Pass/Fail: Fail		Overall Compliance: No		Severity Score: 10	
Codes/Mitigation Info/Possible Solution				Field Measurements/Component Compliance

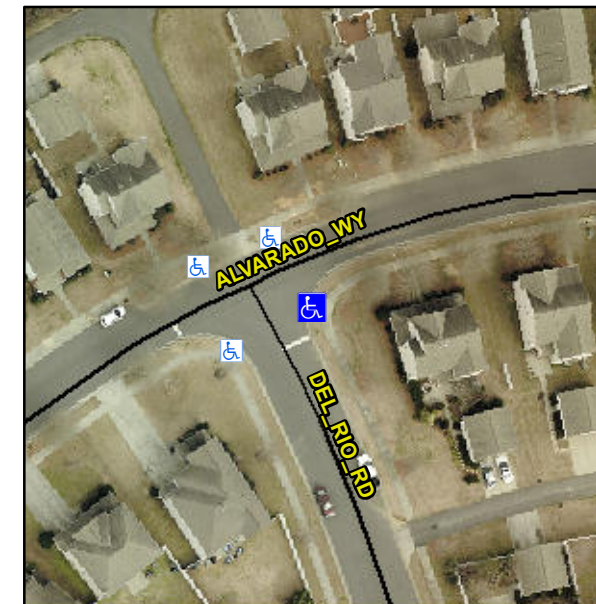
R304.5.1, R304.5.3

Compliance	Description	Data	Compliance	Description	Data
N/A	Ramp Length (in)	73.0	Yes	Ramp Slope (%)	8.1
No	Ramp Width (in)	46.5	No	Ramp XSlope (%)	4.3
N/A	Flare Type LT	N/A	N/A	Flare Type RT	N/A
N/A	Flare Slope LT (%)	N/A	N/A	Flare Slope RT (%)	N/A
N/A	Flare Traversable LT?	N/A	N/A	Flare Traversable RT?	N/A
N/A	Landing Length (in)	N/A	N/A	DWS Provided?	N/A
N/A	Landing Width (in)	N/A	N/A	DWS Contrast?	N/A
N/A	Landing Slope (%)	N/A	N/A	DWS Length (in)	N/A
N/A	Landing X Slope (%)	N/A	N/A	DWS Full Width?	N/A
N/A	Landing Curb? (Y/N)	N/A	N/A	DWS Offset (in)	N/A
N/A	Shared Landing?	N/A			
N/A	Gutter Ponding?	N/A	N/A	Gutter Slope (%)	N/A
N/A	Gutter Lip Ht (in)	N/A	N/A	Gutter X Slope (%)	N/A
N/A	Painted X Walk1?	No	N/A	Painted X Walk2?	No
	X Walk 1 Direction	To NW		X Walk 2 Direction	To SW
N/A	X Walk 1 Width (in)	N/A	N/A	X Walk 2 Width (in)	N/A
	X Walk 1 Slope (%)	1.8		X Walk 2 Slope (%)	0.4
	X Walk 1 X Slope (%)	1.0		X Walk 2 X Slope (%)	2.0

N/A	Ramp inside XWalk1?	N/A	N/A	Ramp inside XWalk2?	N/A
	Road Slope (%)	1.5	N/A	Clear Space?	N/A
	Road X Slope (%)	0.7	N/A	Clear Space to XWalk (in)	N/A
N/A	Any Obstructions?	N/A	N/A	Storm Grate/Utility Hazard?	N/A
	Obstruction Type			Storm Grate/Utility Type	
		N/A			N/A
		Yes		Surface Condition? (G/P)	Good

Possible Solutions:

Remove & Replace Curb Ramp With Two New Directional Ramps or Equivalent.

Total Cost: \$ 3200.00
