Access Compliance Report

Public Rights-of-Way

(Curb Ramps)

Intersection ID: N/A	Main Street: E 8TH ST	Cross Street: N BREVARD ST	Location: S
ADA ID: ABFE00B3E2C9	Ramp Type: Perp	Initial Pass/Fail: Fail	Overall Compliance: No
		Severity Score: 1.25

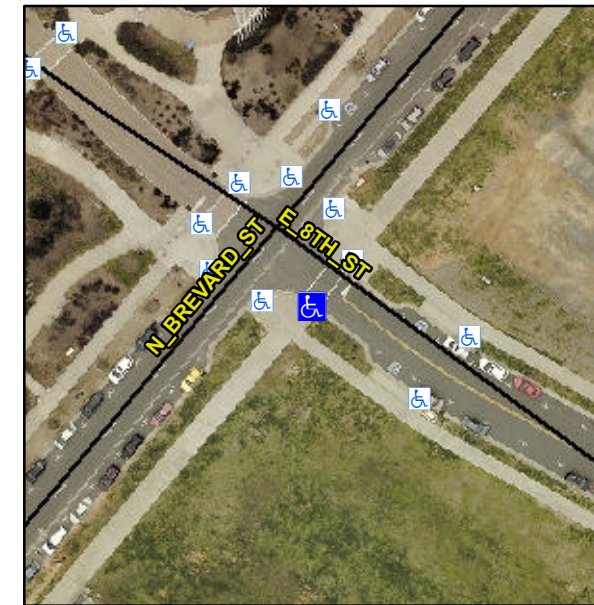
Compliance	Description	Data	Compliance	Description	Data
N/A	Ramp Length (in)	78.5	Yes	Ramp Slope (%)	6.1
Yes	Ramp Width (in)	48.0	No	Ramp XSlope (%)	4.1
N/A	Flare Type LT	N/A	N/A	Flare Type RT	N/A
N/A	Flare Slope LT (%)	N/A	N/A	Flare Slope RT (%)	N/A
N/A	Flare Traversable LT?	No	N/A	Flare Traversable RT?	No
N/A	Landing Length (in)	N/A	N/A	DWS Provided?	N/A
N/A	Landing Width (in)	N/A	N/A	DWS Contrast?	N/A
N/A	Landing Slope (%)	N/A	N/A	DWS Length (in)	N/A
N/A	Landing X Slope (%)	N/A	N/A	DWS Full Width?	N/A
N/A	Landing Curb? (Y/N)	N/A	N/A	DWS Offset (in)	N/A
N/A	Shared Landing?	N/A			
N/A	Gutter Ponding?	N/A	N/A	Gutter Slope (%)	N/A
N/A	Gutter Lip Ht (in)	N/A	N/A	Gutter X Slope (%)	N/A
N/A	Painted X Walk1?	Yes	N/A	Painted X Walk2?	N/A
	X Walk 1 Direction	To NE		X Walk 2 Direction	N/A
N/A	X Walk 1 Width (in)	111.0	N/A	X Walk 2 Width (in)	N/A
	X Walk 1 Slope (%)	2.0		X Walk 2 Slope (%)	N/A
	X Walk 1 X Slope (%)	4.5		X Walk 2 X Slope (%)	N/A

N/A	Ramp inside XWalk1?	Yes	N/A	Ramp inside XWalk2?	N/A
	Road Slope (%)	N/A	N/A	Clear Space?	N/A
	Road X Slope (%)	N/A	N/A	Clear Space to XWalk (in)	N/A
N/A	Any Obstructions?	N/A	N/A	Storm Grate/Utility Hazard?	N/A
	Obstruction Type			Storm Grate/Utility Type	
		N/A			N/A
		Yes		Surface Condition? (G/P)	Good

Possible Solutions:

Remove & Replace Entire Ramp.

R304.5.3
