Access Compliance Report

Public Rights-of-Way

(Curb Ramps)

Intersection ID: 53534	Main Street: N_JOSH_BIRMINGHAM_PY	Cross Street: WILKINSON_BV	Location: NE
ADA ID: AC02B945B107	Ramp Type: Perp	Initial Pass/Fail: Fail	Overall Compliance: No
Codes/Mitigation Info/Possible Solution			Severity Score: 10
			Field Measurements/Component Compliance

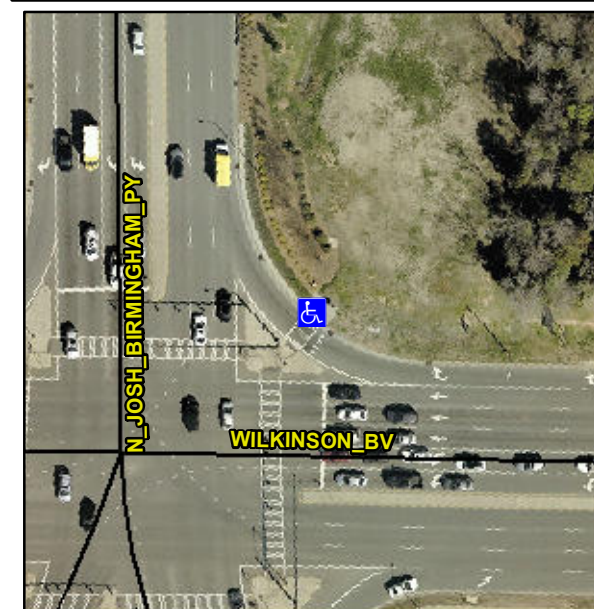
Not Found, R304.5.1, R304.5.3

Compliance	Description	Data	Compliance	Description	Data
N/A	Ramp Length (in)	67.0	Yes	Ramp Slope (%)	7.9
No	Ramp Width (in)	47.0	No	Ramp XSlope (%)	2.5
N/A	Flare Type LT	N/A	N/A	Flare Type RT	N/A
N/A	Flare Slope LT (%)	N/A	N/A	Flare Slope RT (%)	N/A
N/A	Flare Traversable LT?	N/A	N/A	Flare Traversable RT?	N/A
N/A	Landing Length (in)	N/A	N/A	DWS Provided?	N/A
N/A	Landing Width (in)	N/A	N/A	DWS Contrast?	N/A
N/A	Landing Slope (%)	N/A	N/A	DWS Length (in)	N/A
N/A	Landing X Slope (%)	N/A	N/A	DWS Full Width?	N/A
N/A	Landing Curb? (Y/N)	N/A	N/A	DWS Offset (in)	N/A
N/A	Shared Landing?	N/A			
N/A	Gutter Ponding?	N/A	N/A	Gutter Slope (%)	N/A
N/A	Gutter Lip Ht (in)	N/A	N/A	Gutter X Slope (%)	N/A
N/A	Painted X Walk1?	Yes	N/A	Painted X Walk2?	N/A
	X Walk 1 Direction	To SW		X Walk 2 Direction	N/A
N/A	X Walk 1 Width (in)	111.0	N/A	X Walk 2 Width (in)	N/A
	X Walk 1 Slope (%)	2.2		X Walk 2 Slope (%)	N/A
	X Walk 1 X Slope (%)	3.0		X Walk 2 X Slope (%)	N/A

N/A	Ramp inside XWalk1?	Yes	N/A	Ramp inside XWalk2?	N/A
	Road Slope (%)	N/A	N/A	Clear Space?	N/A
	Road X Slope (%)	N/A	N/A	Clear Space to XWalk (in)	N/A
N/A	Any Obstructions?	N/A	N/A	Storm Grate/Utility Hazard?	N/A
	Obstruction Type			Storm Grate/Utility Type	
		N/A			N/A
		Yes		Surface Condition? (G/P)	Good

Possible Solutions:

Remove & Replace Entire Ramp.
