Access Compliance Report

Public Rights-of-Way

(Curb Ramps)

Intersection ID: 10456	Main Street: MORSON_ST	Cross Street: ROSE_ST	Location: NE
ADA ID: AC0AF7EC5BFE	Ramp Type: PerpDiag	Initial Pass/Fail: Fail	Overall Compliance: No
		Severity Score: 10

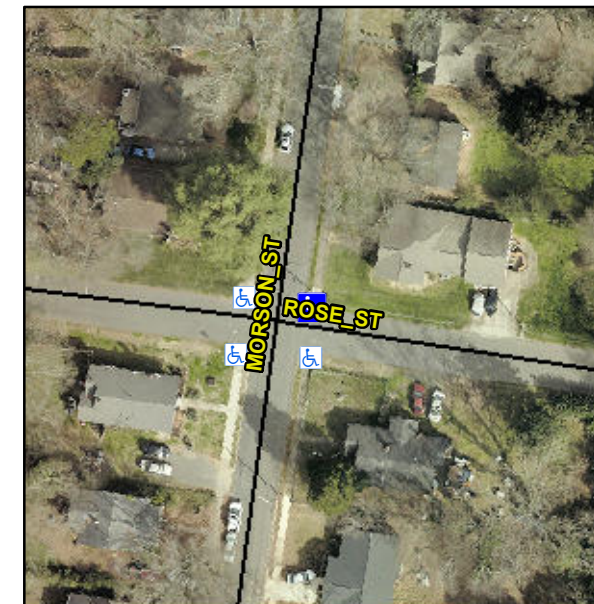
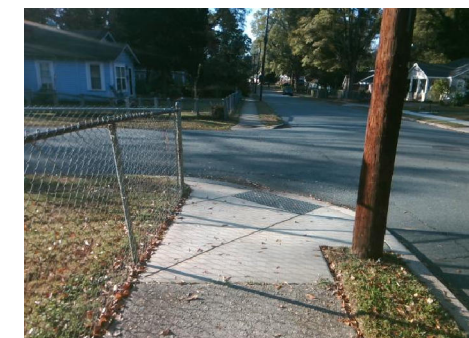
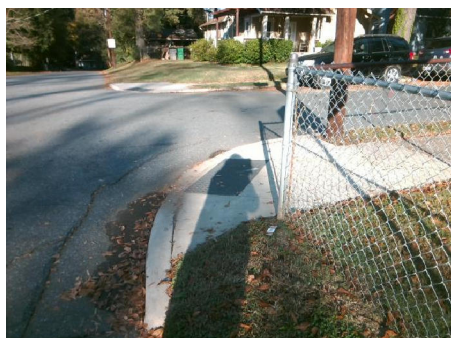
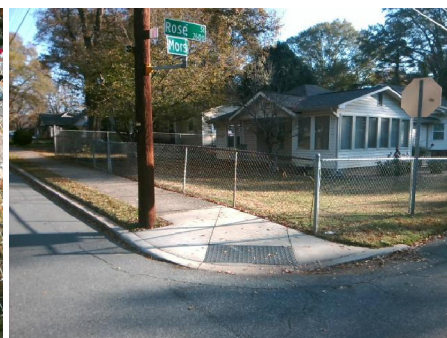
Not Found, R304.5.1, R304.5.3

Compliance	Description	Data	Compliance	Description	Data
N/A	Ramp Length (in)	59.0	Yes	Ramp Slope (%)	6.6
No	Ramp Width (in)	47.5	No	Ramp XSlope (%)	2.9
N/A	Flare Type LT	N/A	N/A	Flare Type RT	N/A
N/A	Flare Slope LT (%)	N/A	N/A	Flare Slope RT (%)	N/A
N/A	Flare Traversable LT?	N/A	N/A	Flare Traversable RT?	N/A
N/A	Landing Length (in)	N/A	N/A	DWS Provided?	N/A
N/A	Landing Width (in)	N/A	N/A	DWS Contrast?	N/A
N/A	Landing Slope (%)	N/A	N/A	DWS Length (in)	N/A
N/A	Landing X Slope (%)	N/A	N/A	DWS Full Width?	N/A
N/A	Landing Curb? (Y/N)	N/A	N/A	DWS Offset (in)	N/A
N/A	Shared Landing?	N/A			
N/A	Gutter Ponding?	N/A	N/A	Gutter Slope (%)	N/A
N/A	Gutter Lip Ht (in)	N/A	N/A	Gutter X Slope (%)	N/A
N/A	Painted X Walk1?	No	N/A	Painted X Walk2?	No
	X Walk 1 Direction	To W		X Walk 2 Direction	To S
N/A	X Walk 1 Width (in)	N/A	N/A	X Walk 2 Width (in)	N/A
	X Walk 1 Slope (%)	6.0		X Walk 2 Slope (%)	0.9
	X Walk 1 X Slope (%)	1.8		X Walk 2 X Slope (%)	1.4

N/A	Ramp inside XWalk1?	N/A	N/A	Ramp inside XWalk2?	N/A
	Road Slope (%)	4.8	N/A	Clear Space?	N/A
	Road X Slope (%)	2.4	N/A	Clear Space to XWalk (in)	N/A
N/A	Any Obstructions?	N/A	N/A	Storm Grate/Utility Hazard?	N/A
	Obstruction Type			Storm Grate/Utility Type	
		N/A			N/A
		Yes		Surface Condition? (G/P)	Good

Remove & Replace Curb Ramp With Two New Directional Ramps or Equivalent.
