Access Compliance Report

Public Rights-of-Way

(Curb Ramps)

Intersection ID: 24849	Main Street: KING_EIDER_DR	Cross Street: WIDGEON_CT	Location: SE
ADA ID: AC0F37CDFBCD	Ramp Type: Directional1	Initial Pass/Fail: Fail	Overall Compliance: No
Severity Score: 37.5			
Codes/Mitigation Info/Possible Solution		Field Measurements/Component Compliance

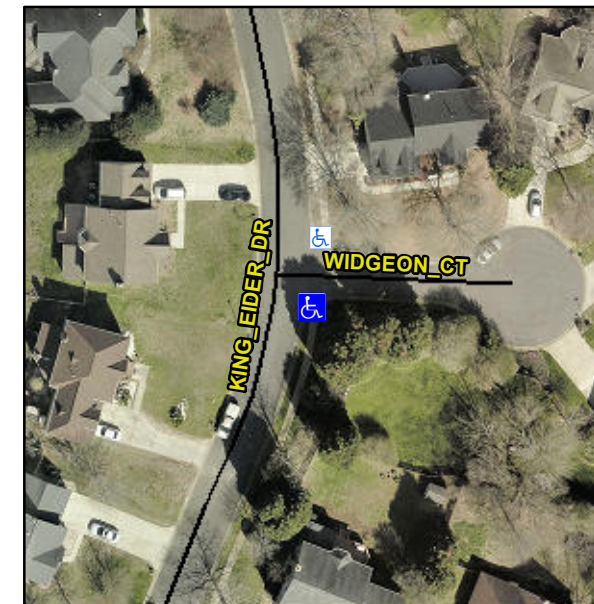
R304.2.2, R304.5.3

Compliance	Description	Data	Compliance	Description	Data
N/A	Ramp Length (in)	25.0	N/A	Grade Break?	N/A
Yes	Ramp Width (in)	48.0	N/A	Grade Break Slope (%)	0.0
No	Ramp Slope (%)	10.9	N/A	Grade Break XSlope (%)	0.0
No	Ramp XSlope (%)	7.2			
N/A	Flare Type LT	N/A	N/A	Flare Type RT	N/A
N/A	Flare Slope LT (%)	N/A	N/A	Flare Slope RT (%)	0.0
N/A	Flare Traversable LT?	N/A	N/A	Flare Traversable RT?	N/A
N/A	Landing Length (in)	0.0	N/A	DWS Provided?	N/A
N/A	Landing Width (in)	0.0	N/A	DWS Contrast?	N/A
N/A	Landing Slope (%)	0.0	N/A	DWS Length (in)	N/A
N/A	Landing X Slope (%)	0.0	N/A	DWS Full Width?	N/A
N/A	Landing Curb? (Y/N)	N/A	N/A	DWS Offset LT (in)	N/A
N/A	Shared Landing?	N/A	N/A	DWS Offset RT (in)	N/A
N/A	Gutter Ponding?	0.0	N/A	Gutter Slope (%)	N/A
N/A	Gutter Lip Ht (in)	0.0	N/A	Gutter X Slope (%)	N/A
N/A	Painted X Walk1?	No		Road Slope (%)	3.3
	X Walk 1 Direction	To N		Road X Slope (%)	3.7
	X Walk 1 Width (in)	N/A		Clear Space?	N/A

X Walk 1 Slope (%)	3.3	N/A	Clear Space to XWalk (in)	N/A
	X Walk 1 X Slope (%)	3.7	N/A	Storm Grate/Utility Hazard?	N/A
N/A	Ramp inside XWalk1?	N/A		Storm Grate/Utility Type	
N/A	Any Obstructions?	N/A			N/A
	Obstruction Type		Yes	Surface Condition? (G/P)	Good
			N/A	Curb Slope (%)	31.3

Possible Solutions:

Remove & Replace Entire Ramp.
