Access Compliance Report

Public Rights-of-Way

(Curb Ramps)

Intersection ID: 31601	Main Street: BULL_RUN_RD	Cross Street: GETALONG_RD	Location: SE
ADA ID: AC18A3ECA713	Ramp Type: Perp	Initial Pass/Fail: Pass	Overall Compliance: No
		Severity Score: 15

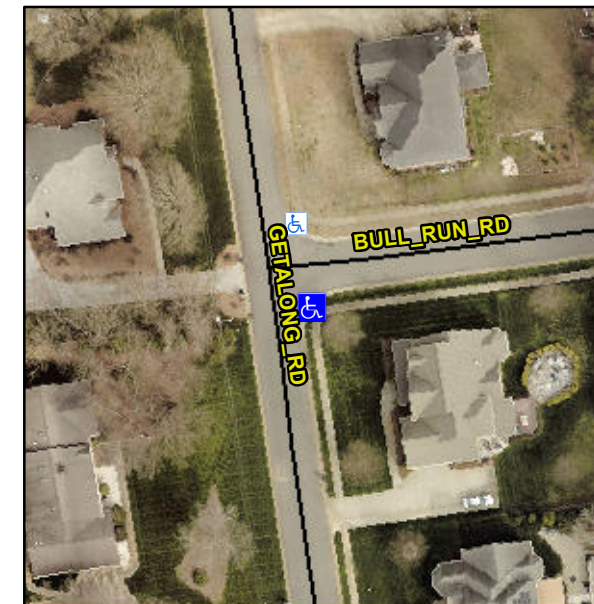
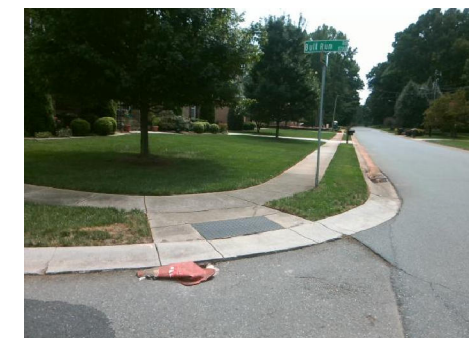
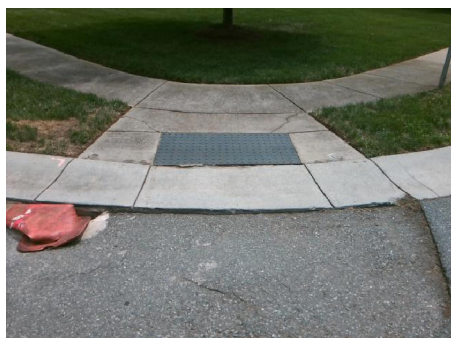
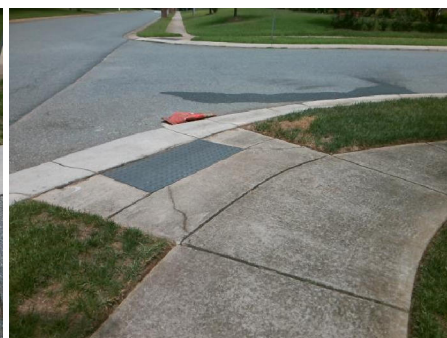
Compliance	Description	Data	Compliance	Description	Data
N/A	Ramp Length (in)	47.0	Yes	Ramp Slope (%)	7.5
Yes	Ramp Width (in)	48.0	Yes	Ramp XSlope (%)	0.6
N/A	Flare Type LT	Sloped	N/A	Flare Type RT	N/A
N/A	Flare Slope LT (%)	5.2	N/A	Flare Slope RT (%)	5.8
N/A	Flare Traversable LT?	No	N/A	Flare Traversable RT?	No
Yes	Landing Length (in)	48.0	Yes	DWS Provided?	Yes
Yes	Landing Width (in)	48.0	Yes	DWS Contrast?	Yes
No	Landing Slope (%)	3.8	Yes	DWS Length (in)	24.0
Yes	Landing X Slope (%)	0.4	Yes	DWS Full Width?	Yes
N/A	Landing Curb? (Y/N)	No	Yes	DWS Offset (in)	1.3
N/A	Shared Landing?	No			
Yes	Gutter Ponding?	No	Yes	Gutter Slope (%)	2.1
No	Gutter Lip Ht (in)	1.0	Yes	Gutter X Slope (%)	0.7
N/A	Painted X Walk1?	No	N/A	Painted X Walk2?	N/A
	X Walk 1 Direction	To N		X Walk 2 Direction	N/A
N/A	X Walk 1 Width (in)	N/A	N/A	X Walk 2 Width (in)	N/A
	X Walk 1 Slope (%)	1.4		X Walk 2 Slope (%)	N/A
	X Walk 1 X Slope (%)	2.1		X Walk 2 X Slope (%)	N/A

N/A	Ramp inside XWalk1?	N/A	N/A	Ramp inside XWalk2?	N/A
	Road Slope (%)	N/A	N/A	Clear Space?	Yes
	Road X Slope (%)	N/A	N/A	Clear Space to XWalk (in)	N/A
Yes	Any Obstructions?	No	Yes	Storm Grate/Utility Hazard?	No
	Obstruction Type			Storm Grate/Utility Type	
		N/A			N/A
			Yes	Surface Condition? (G/P)	Good

Possible Solutions:

Remove & Replace Entire Ramp.

Total Cost: \$ 1850.00
