Intersection ID: 13704	Main Street: CHESTERFIELD_AV	Cross Street: THE_PLAZA	Location:	E
ADA ID: AC1B1405600B	Ramp Type: PerpDiag	Initial Pass/Fail: Fail	Overall Compliance: No	Severity Score: 33.75

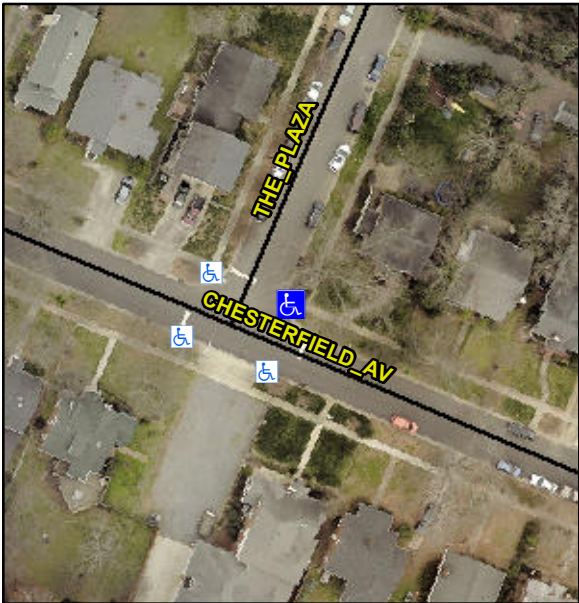
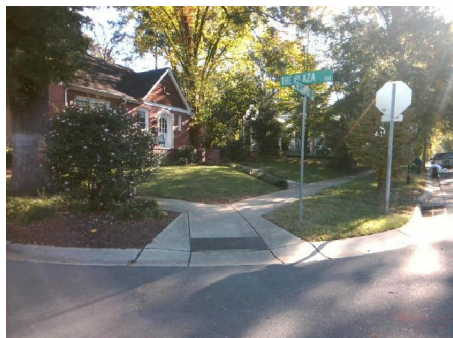
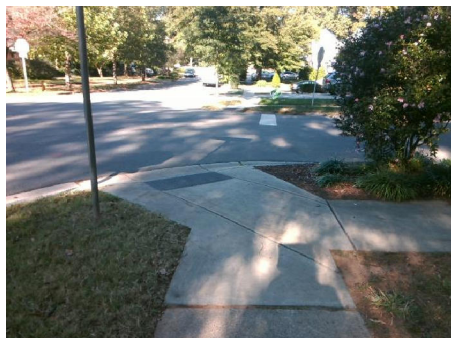
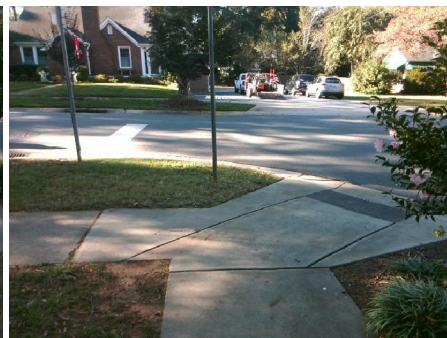
Possible Solutions:		Compliance	Description	Data	Compliance	Description	Data
	<b>Remove &amp; Replace Curb Ramp With Two New Directional Ramps or Equivalent.</b>		N/A	Ramp Length (in)	55.0	No	Ramp Slope (%)	14.1
			No	Ramp Width (in)	45.5	Yes	Ramp XSlope (%)	0.5
			N/A	Flare Type LT	N/A	N/A	Flare Type RT	N/A
			N/A	Flare Slope LT (%)	N/A	N/A	Flare Slope RT (%)	N/A
			N/A	Flare Traversable LT?	N/A	N/A	Flare Traversable RT?	N/A
			N/A	Landing Length (in)	N/A	N/A	DWS Provided?	N/A
			N/A	Landing Width (in)	N/A	N/A	DWS Contrast?	N/A
			N/A	Landing Slope (%)	N/A	N/A	DWS Length (in)	N/A
			N/A	Landing X Slope (%)	N/A	N/A	DWS Full Width?	N/A
Surveyor Notes:		N/A	Landing Curb? (Y/N)	N/A	N/A	DWS Offset (in)	N/A	N/A
PROW/ADA:		N/A	Shared Landing?	N/A				
<b>Not Found, R304.5.1, R304.2.2</b>		N/A	Gutter Ponding?	N/A	N/A	Gutter Slope (%)	N/A	N/A

N/A	Gutter Lip Ht (in)	N/A	N/A	Gutter X Slope (%)	N/A	N/A
		N/A	Painted X Walk1?	No	N/A	Painted X Walk2?	No	No
			X Walk 1 Direction	To NW		X Walk 2 Direction	To SW	
		N/A	X Walk 1 Width (in)	N/A	N/A	X Walk 2 Width (in)	N/A	N/A
			X Walk 1 Slope (%)	3.7		X Walk 2 Slope (%)	1.2	
			X Walk 1 X Slope (%)	2.4		X Walk 2 X Slope (%)	2.8	
		N/A	Ramp inside XWalk1?	N/A	N/A	Ramp inside XWalk2?	N/A	N/A
			Road Slope (%)	2.7	N/A	Clear Space?	N/A	N/A
			Road X Slope (%)	3.5	N/A	Clear Space to XWalk (in)	N/A	N/A
		N/A	Any Obstructions?	N/A	N/A	Storm Grate/Utility Hazard?	N/A	N/A
			Obstruction Type			Storm Grate/Utility Type		
				N/A			N/A	N/A
					Yes	Surface Condition? (G/P)	Good	Good
Total Cost:		\$ 3200.00						
Street 1 Name		THE PLAZA						
Stop Condition-Street 2		StopSign						
Street 2 Name		CHESTERFIELD AV						
Stop Condition-Street 1		StopSign
