Access Compliance Report

Public Rights-of-Way

(Curb Ramps)

Intersection ID: 10016341	Main Street: UNIVERSITY_CITY_BV	Cross Street: N/A	Location: NW
ADA ID: AC1D6E4F1676	Ramp Type: Directional1	Initial Pass/Fail: Pass	Overall Compliance: No
		Severity Score: 17.5

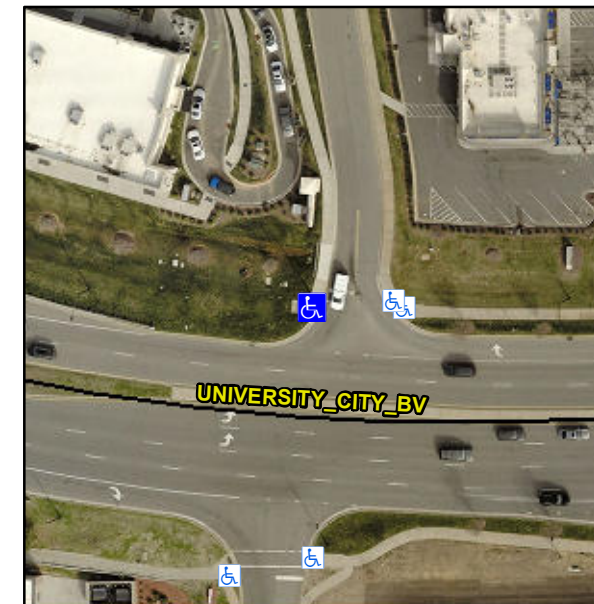
NO LNDG

R304.2.1, R304.2.2-Perp, R304.3.2-Para, R304.5.3, R304.2.3, R305.1.4, R305.2

Compliance	Description	Data	Compliance	Description	Data
N/A	Ramp Length (in)	146.0	Yes	Grade Break?	Yes
Yes	Ramp Width (in)	68.0	Yes	Grade Break Slope (%)	3.7
Yes	Ramp Slope (%)	4.2	Yes	Grade Break XSlope (%)	0.7
Yes	Ramp XSlope (%)	1.2			
Yes	Flare Type LT	N/A	No	Flare Type RT	N/A
N/A	Flare Slope LT (%)	N/A	N/A	Flare Slope RT (%)	3.1
N/A	Flare Traversable LT?	No	N/A	Flare Traversable RT?	No
No	Landing Length (in)	N/A	Yes	DWS Provided?	Yes
No	Landing Width (in)	N/A	Yes	DWS Contrast?	Yes
No	Landing Slope (%)	N/A	Yes	DWS Length (in)	24.0
No	Landing X Slope (%)	N/A	No	DWS Full Width?	No
N/A	Landing Curb? (Y/N)	N/A	No	DWS Offset LT (in)	40.0
N/A	Shared Landing?	No	No	DWS Offset RT (in)	67.0
Yes	Gutter Ponding?	No	Yes	Gutter Slope (%)	0.6
Yes	Gutter Lip Ht (in)	0.0	Yes	Gutter X Slope (%)	0.7
N/A	Painted X Walk1?	No		Road Slope (%)	0.7
	X Walk 1 Direction	To E		Road X Slope (%)	0.8
	X Walk 1 Width (in)	N/A		Clear Space?	Yes

Remove & Replace Entire Ramp.

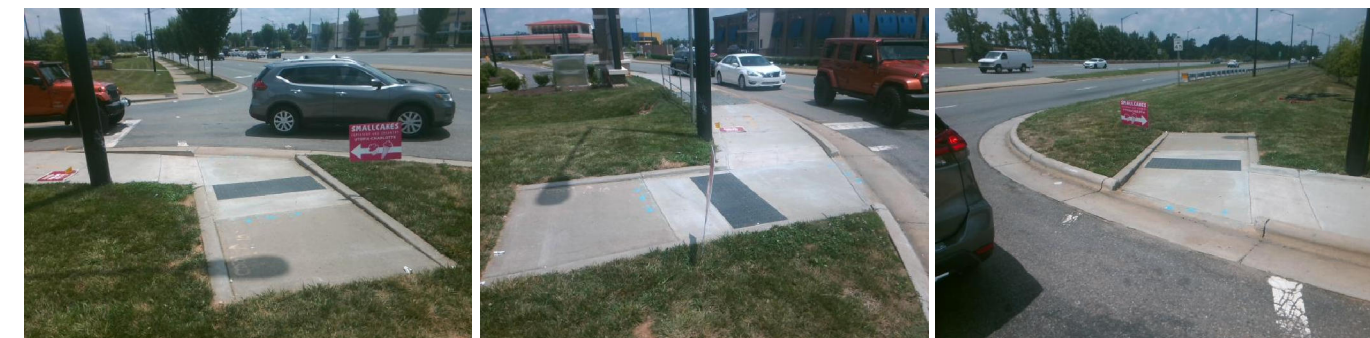
X Walk 1 Slope (%)	0.7	N/A	Clear Space to XWalk (in)	N/A
	X Walk 1 X Slope (%)	0.8	Yes	Storm Grate/Utility Hazard?	No
N/A	Ramp inside XWalk1?	N/A		Storm Grate/Utility Type	
Yes	Any Obstructions?	No			N/A
	Obstruction Type		Yes	Surface Condition? (G/P)	Good
			N/A	Curb Slope (%)	6.4

Possible Solutions:
