Access Compliance Report

Public Rights-of-Way

(Curb Ramps)

Intersection ID: 11169	Main Street: DRUMMOND_AV	Cross Street: LOLA_AV	Location:	S
ADA ID: AC1FC9A54D01	Ramp Type: Perp	Initial Pass/Fail: Fail	Overall Compliance: No	Severity Score: 25

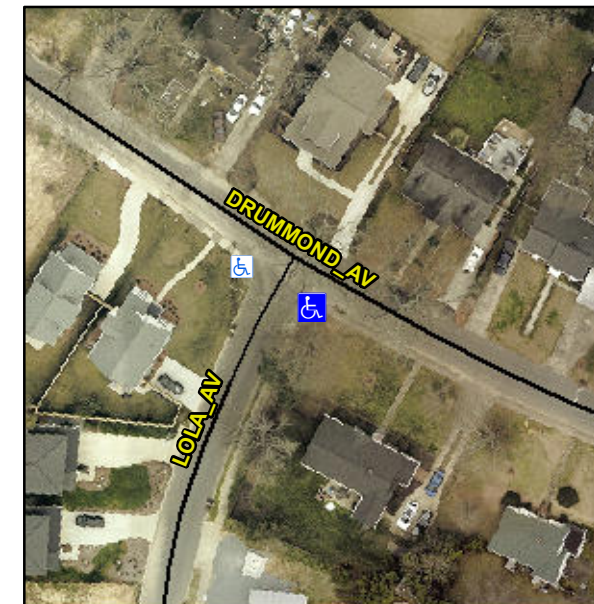
Not Found, R304.2.2

Compliance	Description	Data	Compliance	Description	Data
N/A	Ramp Length (in)	59.0	No	Ramp Slope (%)	14.7
Yes	Ramp Width (in)	81.0	Yes	Ramp XSlope (%)	0.6
N/A	Flare Type LT	N/A	N/A	Flare Type RT	N/A
N/A	Flare Slope LT (%)	N/A	N/A	Flare Slope RT (%)	N/A
N/A	Flare Traversable LT?	N/A	N/A	Flare Traversable RT?	N/A
N/A	Landing Length (in)	N/A	N/A	DWS Provided?	N/A
N/A	Landing Width (in)	N/A	N/A	DWS Contrast?	N/A
N/A	Landing Slope (%)	N/A	N/A	DWS Length (in)	N/A
N/A	Landing X Slope (%)	N/A	N/A	DWS Full Width?	N/A
N/A	Landing Curb? (Y/N)	N/A	N/A	DWS Offset (in)	N/A
N/A	Shared Landing?	N/A			
N/A	Gutter Ponding?	N/A	N/A	Gutter Slope (%)	N/A
N/A	Gutter Lip Ht (in)	N/A	N/A	Gutter X Slope (%)	N/A
N/A	Painted X Walk1?	No	N/A	Painted X Walk2?	N/A
	X Walk 1 Direction	To NW		X Walk 2 Direction	N/A
N/A	X Walk 1 Width (in)	N/A	N/A	X Walk 2 Width (in)	N/A
	X Walk 1 Slope (%)	0.8		X Walk 2 Slope (%)	N/A
	X Walk 1 X Slope (%)	4.4		X Walk 2 X Slope (%)	N/A

Remove & Replace Entire Ramp.
