Access Compliance Report

Public Rights-of-Way

(Curb Ramps)

Intersection ID: 10005	Main Street: ROSLYN_AV	Cross Street: S_GARDNER_AV	Location: S
ADA ID: AC25991AD99A	Ramp Type: Perp	Initial Pass/Fail: Fail	Overall Compliance: No
		Severity Score: 10

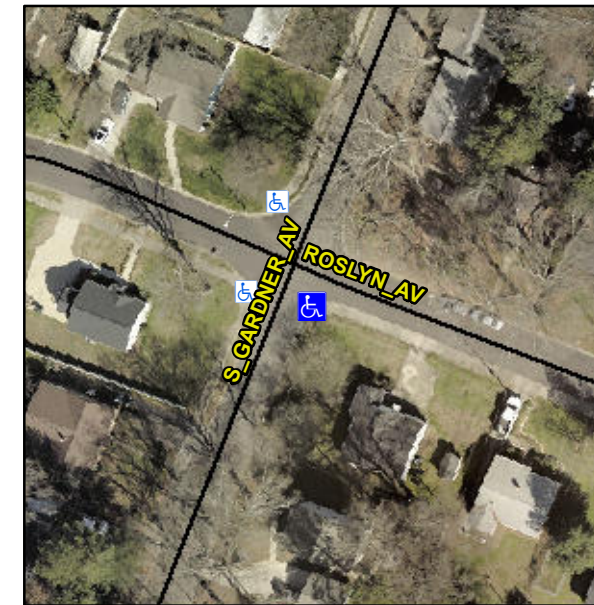
Not Found, R304.5.1, R304.5.3

Compliance	Description	Data	Compliance	Description	Data
N/A	Ramp Length (in)	72.0	Yes	Ramp Slope (%)	6.0
No	Ramp Width (in)	47.0	No	Ramp XSlope (%)	2.3
N/A	Flare Type LT	N/A	N/A	Flare Type RT	N/A
N/A	Flare Slope LT (%)	N/A	N/A	Flare Slope RT (%)	N/A
N/A	Flare Traversable LT?	N/A	N/A	Flare Traversable RT?	N/A
N/A	Landing Length (in)	N/A	N/A	DWS Provided?	N/A
N/A	Landing Width (in)	N/A	N/A	DWS Contrast?	N/A
N/A	Landing Slope (%)	N/A	N/A	DWS Length (in)	N/A
N/A	Landing X Slope (%)	N/A	N/A	DWS Full Width?	N/A
N/A	Landing Curb? (Y/N)	N/A	N/A	DWS Offset (in)	N/A
N/A	Shared Landing?	N/A			
N/A	Gutter Ponding?	N/A	N/A	Gutter Slope (%)	N/A
N/A	Gutter Lip Ht (in)	N/A	N/A	Gutter X Slope (%)	N/A
N/A	Painted X Walk1?	No	N/A	Painted X Walk2?	N/A
	X Walk 1 Direction	To NW		X Walk 2 Direction	N/A
N/A	X Walk 1 Width (in)	N/A	N/A	X Walk 2 Width (in)	N/A
	X Walk 1 Slope (%)	3.1		X Walk 2 Slope (%)	N/A
	X Walk 1 X Slope (%)	0.7		X Walk 2 X Slope (%)	N/A

N/A	Ramp inside XWalk1?	N/A	N/A	Ramp inside XWalk2?	N/A
	Road Slope (%)	N/A	N/A	Clear Space?	N/A
	Road X Slope (%)	N/A	N/A	Clear Space to XWalk (in)	N/A
N/A	Any Obstructions?	N/A	N/A	Storm Grate/Utility Hazard?	N/A
	Obstruction Type			Storm Grate/Utility Type	
		N/A			N/A
			Yes	Surface Condition? (G/P)	Good

Possible Solutions:

Remove & Replace Entire Ramp.
