Access Compliance Report

Public Rights-of-Way

(Curb Ramps)

Intersection ID: 10036288	Main Street: ROSE RIDGE PL	Cross Street: N/A	Location: SW
ADA ID: AC2D9079FCF7	Ramp Type: Perp	Initial Pass/Fail: Fail	Overall Compliance: No
Codes/Mitigation Info/Possible Solution		Field Measurements/Component Compliance	
Severity Score: 13.75

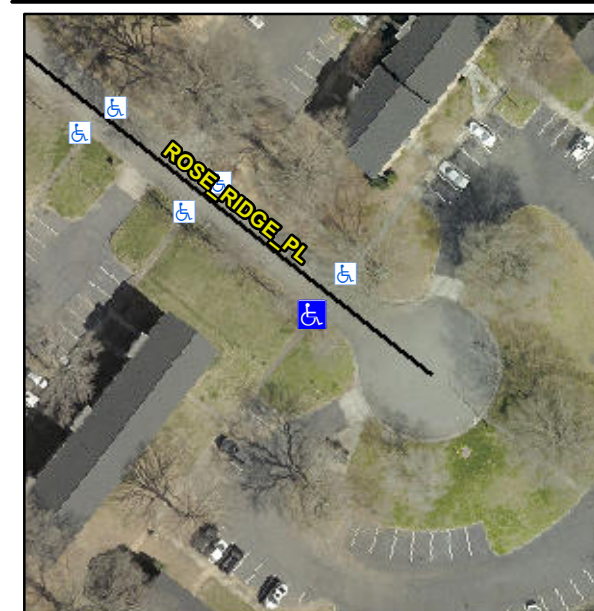
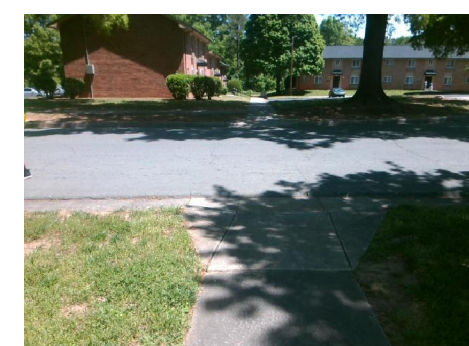
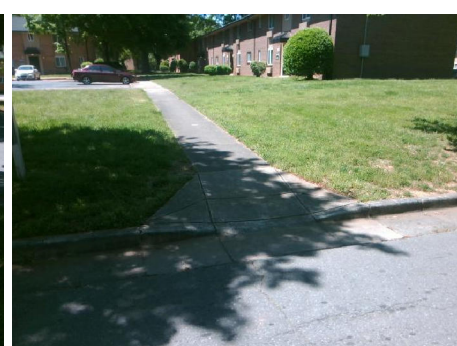
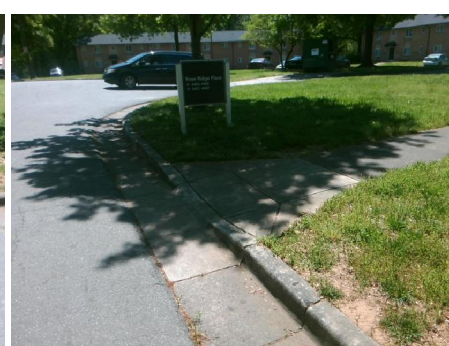
Not Found, R304.2.2, R304.5.3

Compliance	Description	Data	Compliance	Description	Data
N/A	Ramp Length (in)	61.0	No	Ramp Slope (%)	10.5
Yes	Ramp Width (in)	48.0	No	Ramp XSlope (%)	3.8
N/A	Flare Type LT	N/A	N/A	Flare Type RT	N/A
N/A	Flare Slope LT (%)	N/A	N/A	Flare Slope RT (%)	N/A
N/A	Flare Traversable LT?	N/A	N/A	Flare Traversable RT?	N/A
N/A	Landing Length (in)	N/A	N/A	DWS Provided?	N/A
N/A	Landing Width (in)	N/A	N/A	DWS Contrast?	N/A
N/A	Landing Slope (%)	N/A	N/A	DWS Length (in)	N/A
N/A	Landing X Slope (%)	N/A	N/A	DWS Full Width?	N/A
N/A	Landing Curb? (Y/N)	N/A	N/A	DWS Offset (in)	N/A
N/A	Shared Landing?	N/A			
N/A	Gutter Ponding?	N/A	N/A	Gutter Slope (%)	N/A
N/A	Gutter Lip Ht (in)	1.5	N/A	Gutter X Slope (%)	N/A
N/A	Painted X Walk1?	No	N/A	Painted X Walk2?	N/A
	X Walk 1 Direction	To NE		X Walk 2 Direction	N/A
N/A	X Walk 1 Width (in)	N/A	N/A	X Walk 2 Width (in)	N/A
	X Walk 1 Slope (%)	6.8		X Walk 2 Slope (%)	N/A
	X Walk 1 X Slope (%)	1.2		X Walk 2 X Slope (%)	N/A

N/A	Ramp inside XWalk1?	N/A	N/A	Ramp inside XWalk2?	N/A
	Road Slope (%)	N/A	N/A	Clear Space?	N/A
	Road X Slope (%)	N/A	N/A	Clear Space to XWalk (in)	N/A
N/A	Any Obstructions?	N/A	N/A	Storm Grate/Utility Hazard?	N/A
	Obstruction Type			Storm Grate/Utility Type	
		N/A			N/A
			Yes	Surface Condition? (G/P)	Good

Possible Solutions:

Remove & Replace Entire Ramp.
