Access Compliance Report

Public Rights-of-Way

(Curb Ramps)

Intersection ID: 47585	Main Street: EVANTON_LOCH_RD	Cross Street: SEAMILL_RD	Location: NW
ADA ID: AC320B53B8E3	Ramp Type: Perp	Initial Pass/Fail: Pass	Overall Compliance: No
Codes/Mitigation Info/Possible Solution		Field Measurements/Component Compliance	
Severity Score: 0.25

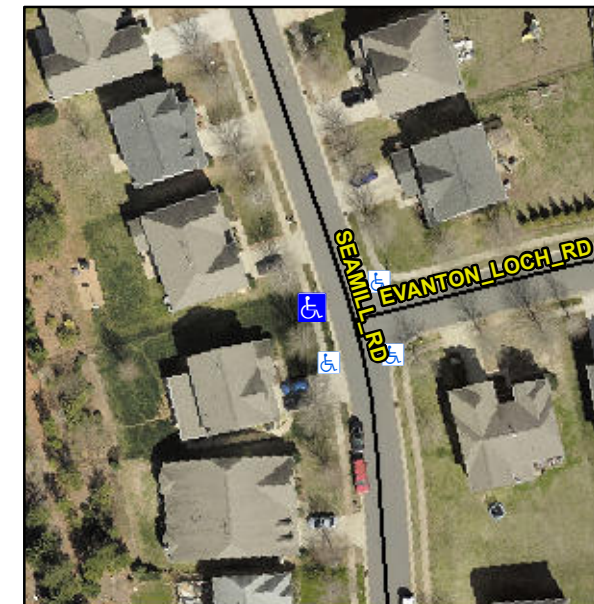
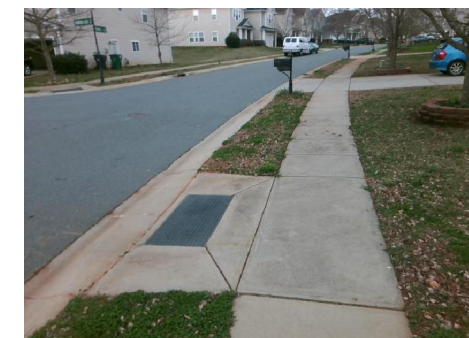
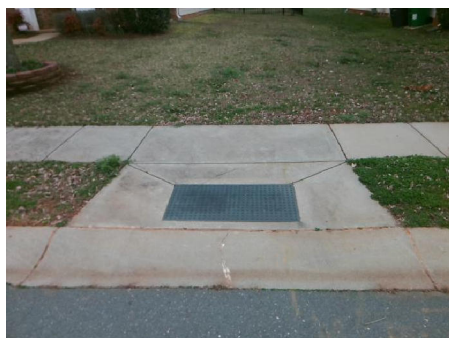
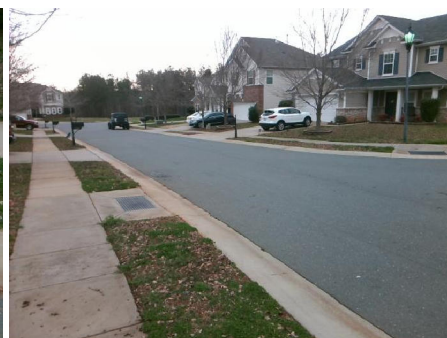
Compliance	Description	Data	Compliance	Description	Data
N/A	Ramp Length (in)	46.0	Yes	Ramp Slope (%)	7.3
Yes	Ramp Width (in)	48.0	Yes	Ramp XSlope (%)	2.4
N/A	Flare Type LT	Sloped	N/A	Flare Type RT	N/A
N/A	Flare Slope LT (%)	5.4	N/A	Flare Slope RT (%)	0.8
N/A	Flare Traversable LT?	No	N/A	Flare Traversable RT?	No
Yes	Landing Length (in)	48.0	Yes	DWS Provided?	Yes
Yes	Landing Width (in)	48.0	Yes	DWS Contrast?	Yes
No	Landing Slope (%)	4.7	Yes	DWS Length (in)	24.5
Yes	Landing X Slope (%)	2.2	Yes	DWS Full Width?	Yes
N/A	Landing Curb? (Y/N)	No	No	DWS Offset (in)	4.0
N/A	Shared Landing?	No			
Yes	Gutter Ponding?	No	Yes	Gutter Slope (%)	3.1
Yes	Gutter Lip Ht (in)	0.0	No	Gutter X Slope (%)	3.3
N/A	Painted X Walk1?	No	N/A	Painted X Walk2?	N/A
	X Walk 1 Direction	To E		X Walk 2 Direction	N/A
N/A	X Walk 1 Width (in)	N/A	N/A	X Walk 2 Width (in)	N/A
	X Walk 1 Slope (%)	3.3		X Walk 2 Slope (%)	N/A
	X Walk 1 X Slope (%)	2.9		X Walk 2 X Slope (%)	N/A

N/A	Ramp inside XWalk1?	N/A	N/A	Ramp inside XWalk2?	N/A
	Road Slope (%)	N/A	N/A	Clear Space?	Yes
	Road X Slope (%)	N/A	N/A	Clear Space to XWalk (in)	N/A
Yes	Any Obstructions?	No	Yes	Storm Grate/Utility Hazard?	No
	Obstruction Type			Storm Grate/Utility Type	
		N/A			N/A
			Yes	Surface Condition? (G/P)	Good

Possible Solutions:

**Remove & Replace Entire Ramp.
Remove & Replace Gutter.**

**R304.2.2-Perp, R304.3.2-Para,
R305.2, R304.5.3**
