Access Compliance Report

Public Rights-of-Way

(Curb Ramps)

Intersection ID: 10146	Main Street: TUCKASEEGEE_RD	Cross Street: YAHTZEE_LN	Location: NE
ADA ID: AC37A9F7270E	Ramp Type: PerpDiag	Initial Pass/Fail: Fail	Overall Compliance: No
Severity Score: 8.75			
Codes/Mitigation Info/Possible Solution		Field Measurements/Component Compliance

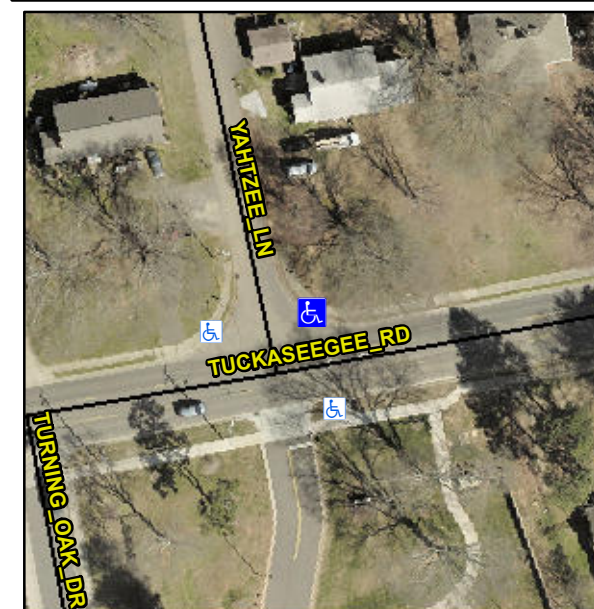
Not Found, R304.5.1

Compliance	Description	Data	Compliance	Description	Data
N/A	Ramp Length (in)	81.0	Yes	Ramp Slope (%)	6.2
No	Ramp Width (in)	44.0	Yes	Ramp XSlope (%)	1.5
N/A	Flare Type LT	N/A	N/A	Flare Type RT	N/A
N/A	Flare Slope LT (%)	N/A	N/A	Flare Slope RT (%)	N/A
N/A	Flare Traversable LT?	N/A	N/A	Flare Traversable RT?	N/A
N/A	Landing Length (in)	N/A	N/A	DWS Provided?	N/A
N/A	Landing Width (in)	N/A	N/A	DWS Contrast?	N/A
N/A	Landing Slope (%)	N/A	N/A	DWS Length (in)	N/A
N/A	Landing X Slope (%)	N/A	N/A	DWS Full Width?	N/A
N/A	Landing Curb? (Y/N)	N/A	N/A	DWS Offset (in)	N/A
N/A	Shared Landing?	N/A			
N/A	Gutter Ponding?	N/A	N/A	Gutter Slope (%)	N/A
N/A	Gutter Lip Ht (in)	N/A	N/A	Gutter X Slope (%)	N/A
N/A	Painted X Walk1?	No	N/A	Painted X Walk2?	No
	X Walk 1 Direction	To W		X Walk 2 Direction	To S
N/A	X Walk 1 Width (in)	N/A	N/A	X Walk 2 Width (in)	N/A
	X Walk 1 Slope (%)	3.0		X Walk 2 Slope (%)	0.2
	X Walk 1 X Slope (%)	0.2		X Walk 2 X Slope (%)	3.0

N/A	Ramp inside XWalk1?	N/A	N/A	Ramp inside XWalk2?	N/A
	Road Slope (%)	0.2	N/A	Clear Space?	N/A
	Road X Slope (%)	3.5	N/A	Clear Space to XWalk (in)	N/A
N/A	Any Obstructions?	N/A	N/A	Storm Grate/Utility Hazard?	N/A
	Obstruction Type			Storm Grate/Utility Type	
		N/A			N/A
		Yes		Surface Condition? (G/P)	Good

Remove & Replace Curb Ramp With Two New Directional Ramps or Equivalent.
