Access Compliance Report

Public Rights-of-Way

(Curb Ramps)

Intersection ID: 15107	Main Street: CHARLOTTE_DR	Cross Street: EAST_BV	Location: SW
ADA ID: AC3DCE53BD80	Ramp Type: Perp	Initial Pass/Fail: Fail	Overall Compliance: No
Severity Score: 22.5			
Codes/Mitigation Info/Possible Solution		Field Measurements/Component Compliance

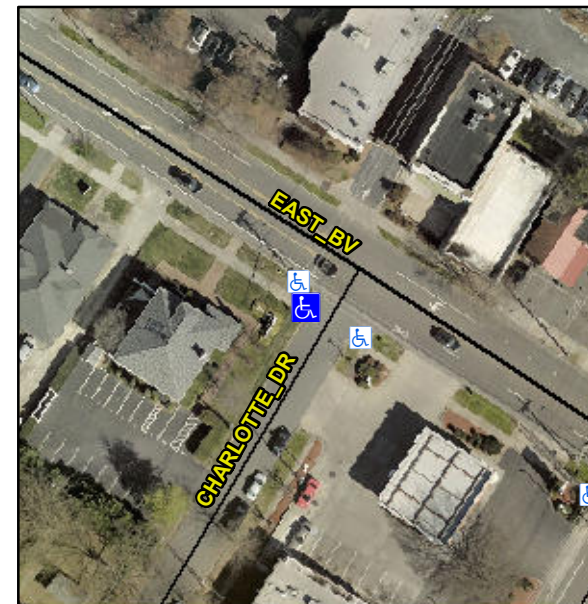
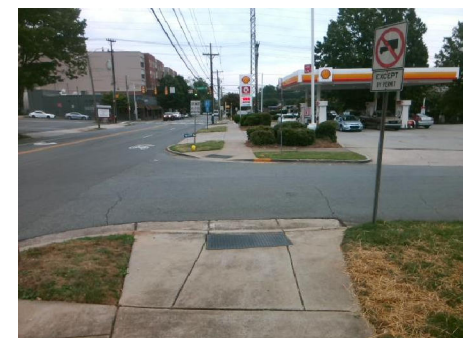
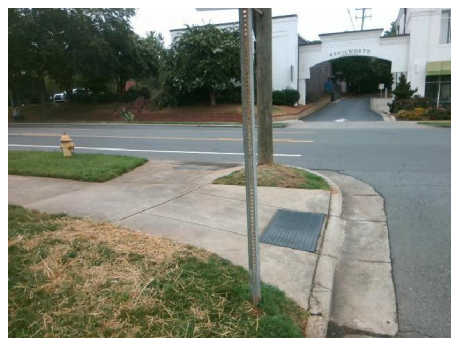
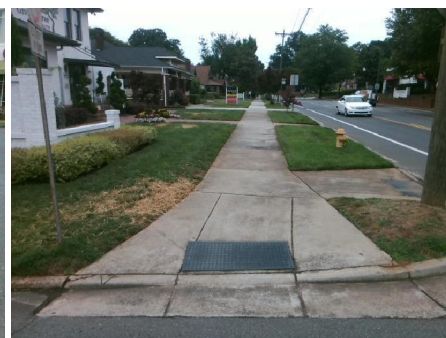
Not Found, R304.5.1, R304.2.2, R304.5.3

Compliance	Description	Data	Compliance	Description	Data
N/A	Ramp Length (in)	96.0	No	Ramp Slope (%)	9.1
No	Ramp Width (in)	47.0	No	Ramp XSlope (%)	3.9
N/A	Flare Type LT	N/A	N/A	Flare Type RT	N/A
N/A	Flare Slope LT (%)	N/A	N/A	Flare Slope RT (%)	N/A
N/A	Flare Traversable LT?	N/A	N/A	Flare Traversable RT?	N/A
N/A	Landing Length (in)	N/A	N/A	DWS Provided?	N/A
N/A	Landing Width (in)	N/A	N/A	DWS Contrast?	N/A
N/A	Landing Slope (%)	N/A	N/A	DWS Length (in)	N/A
N/A	Landing X Slope (%)	N/A	N/A	DWS Full Width?	N/A
N/A	Landing Curb? (Y/N)	N/A	N/A	DWS Offset (in)	N/A
N/A	Shared Landing?	N/A			
N/A	Gutter Ponding?	N/A	N/A	Gutter Slope (%)	N/A
N/A	Gutter Lip Ht (in)	N/A	N/A	Gutter X Slope (%)	N/A
N/A	Painted X Walk1?	No	N/A	Painted X Walk2?	N/A
	X Walk 1 Direction	To SE		X Walk 2 Direction	N/A
N/A	X Walk 1 Width (in)	N/A	N/A	X Walk 2 Width (in)	N/A
	X Walk 1 Slope (%)	3.4		X Walk 2 Slope (%)	N/A
	X Walk 1 X Slope (%)	1.5		X Walk 2 X Slope (%)	N/A

N/A	Ramp inside XWalk1?	N/A	N/A	Ramp inside XWalk2?	N/A
	Road Slope (%)	N/A	N/A	Clear Space?	N/A
	Road X Slope (%)	N/A	N/A	Clear Space to XWalk (in)	N/A
N/A	Any Obstructions?	N/A	N/A	Storm Grate/Utility Hazard?	N/A
	Obstruction Type			Storm Grate/Utility Type	
		N/A			N/A
			Yes	Surface Condition? (G/P)	Good

Remove & Replace Entire Ramp.

Total Cost: \$ 1850.00
