# Access Compliance Report

## Public Rights-of-Way

### (Curb Ramps)

Intersection ID: 52624	Main Street: CORMWELL_LN	Cross Street: CONTEMPORARY_PL	Location: W
ADA ID: AC3E21DF166C	Ramp Type: Perp	Initial Pass/Fail: Fail	Overall Compliance: No
Severity Score: 37.5			
Codes/Mitigation Info/Possible Solution		Field Measurements/Component Compliance

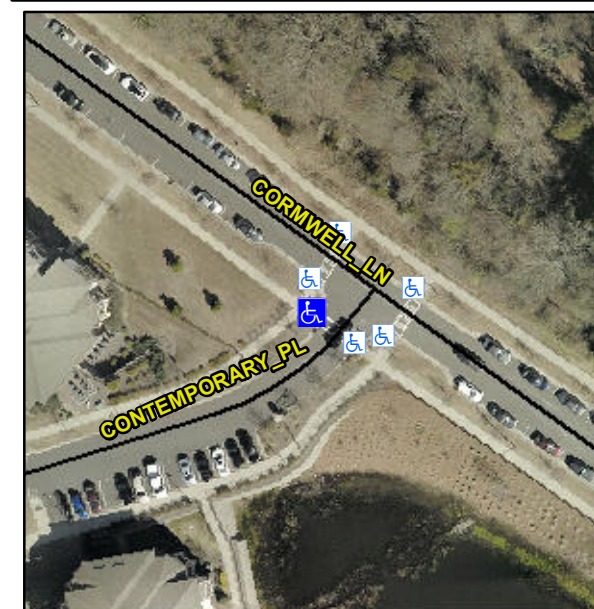
**Not Found, R304.2.2, R304.5.3**

Compliance	Description	Data	Compliance	Description	Data
N/A	Ramp Length (in)	98.0	No	Ramp Slope (%)	13.0
Yes	Ramp Width (in)	56.0	No	Ramp XSlope (%)	6.0
N/A	Flare Type LT	N/A	N/A	Flare Type RT	N/A
N/A	Flare Slope LT (%)	N/A	N/A	Flare Slope RT (%)	N/A
N/A	Flare Traversable LT?	N/A	N/A	Flare Traversable RT?	N/A
N/A	Landing Length (in)	N/A	N/A	DWS Provided?	N/A
N/A	Landing Width (in)	N/A	N/A	DWS Contrast?	N/A
N/A	Landing Slope (%)	N/A	N/A	DWS Length (in)	N/A
N/A	Landing X Slope (%)	N/A	N/A	DWS Full Width?	N/A
N/A	Landing Curb? (Y/N)	N/A	N/A	DWS Offset (in)	N/A
N/A	Shared Landing?	N/A			
N/A	Gutter Ponding?	N/A	N/A	Gutter Slope (%)	N/A
N/A	Gutter Lip Ht (in)	N/A	N/A	Gutter X Slope (%)	N/A
N/A	Painted X Walk1?	Yes	N/A	Painted X Walk2?	N/A
	X Walk 1 Direction	To SE		X Walk 2 Direction	N/A
N/A	X Walk 1 Width (in)	63.0	N/A	X Walk 2 Width (in)	N/A
	X Walk 1 Slope (%)	2.0		X Walk 2 Slope (%)	N/A
	X Walk 1 X Slope (%)	5.0		X Walk 2 X Slope (%)	N/A

N/A	Ramp inside XWalk1?	Yes	N/A	Ramp inside XWalk2?	N/A
	Road Slope (%)	N/A	N/A	Clear Space?	N/A
	Road X Slope (%)	N/A	N/A	Clear Space to XWalk (in)	N/A
N/A	Any Obstructions?	N/A	N/A	Storm Grate/Utility Hazard?	N/A
	Obstruction Type			Storm Grate/Utility Type	
		N/A			N/A
			Yes	Surface Condition? (G/P)	Good

**Remove & Replace Entire Ramp.**
