Access Compliance Report

Public Rights-of-Way

(Curb Ramps)

Intersection ID: 3060	Main Street: BLACK_MAPLE_AV	Cross Street: BROWNE_RD	Location: NW
ADA ID: AC4369BE7743	Ramp Type: Perp	Initial Pass/Fail: Fail	Overall Compliance: No
Severity Score: 35			
Codes/Mitigation Info/Possible Solution		Field Measurements/Component Compliance

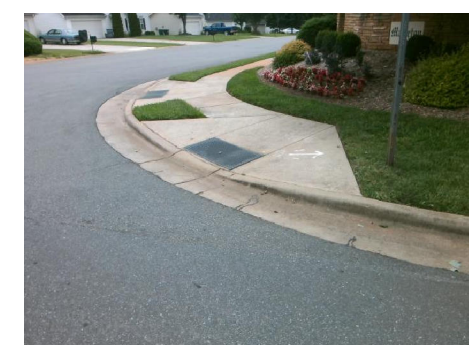
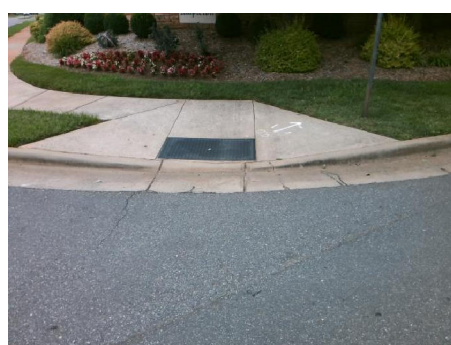
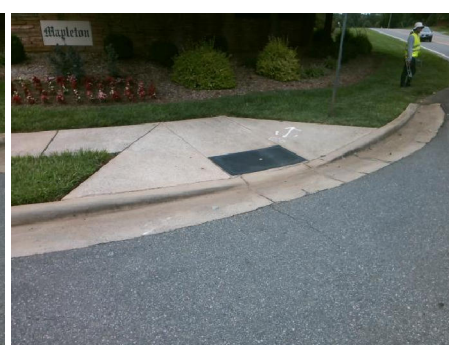
R304.5.1, R304.2.2, R304.5.3

Compliance	Description	Data	Compliance	Description	Data
N/A	Ramp Length (in)	96.0	No	Ramp Slope (%)	20.0
No	Ramp Width (in)	39.5	No	Ramp XSlope (%)	2.7
N/A	Flare Type LT	N/A	N/A	Flare Type RT	N/A
N/A	Flare Slope LT (%)	N/A	N/A	Flare Slope RT (%)	N/A
N/A	Flare Traversable LT?	N/A	N/A	Flare Traversable RT?	N/A
N/A	Landing Length (in)	N/A	N/A	DWS Provided?	N/A
N/A	Landing Width (in)	N/A	N/A	DWS Contrast?	N/A
N/A	Landing Slope (%)	N/A	N/A	DWS Length (in)	N/A
N/A	Landing X Slope (%)	N/A	N/A	DWS Full Width?	N/A
N/A	Landing Curb? (Y/N)	N/A	N/A	DWS Offset (in)	N/A
N/A	Shared Landing?	N/A			
N/A	Gutter Ponding?	N/A	N/A	Gutter Slope (%)	N/A
N/A	Gutter Lip Ht (in)	N/A	N/A	Gutter X Slope (%)	N/A
N/A	Painted X Walk1?	No	N/A	Painted X Walk2?	N/A
	X Walk 1 Direction	To E		X Walk 2 Direction	N/A
N/A	X Walk 1 Width (in)	N/A	N/A	X Walk 2 Width (in)	N/A
	X Walk 1 Slope (%)	5.5		X Walk 2 Slope (%)	N/A
	X Walk 1 X Slope (%)	0.5		X Walk 2 X Slope (%)	N/A

N/A	Ramp inside XWalk1?	N/A	N/A	Ramp inside XWalk2?	N/A
	Road Slope (%)	N/A	N/A	Clear Space?	N/A
	Road X Slope (%)	N/A	N/A	Clear Space to XWalk (in)	N/A
N/A	Any Obstructions?	N/A	N/A	Storm Grate/Utility Hazard?	N/A
	Obstruction Type			Storm Grate/Utility Type	
		N/A			N/A
			Yes	Surface Condition? (G/P)	Good

Remove & Replace Entire Ramp.
