Access Compliance Report

Public Rights-of-Way

(Curb Ramps)

Intersection ID: 48600	Main Street: LITTLE_GEM_LN	Cross Street: GRANDIFLORA_DR	Location: W
ADA ID: AC502E8CFDBD	Ramp Type: Perp	Initial Pass/Fail: Fail	Overall Compliance: No
Severity Score: 13.75			
Codes/Mitigation Info/Possible Solution		Field Measurements/Component Compliance

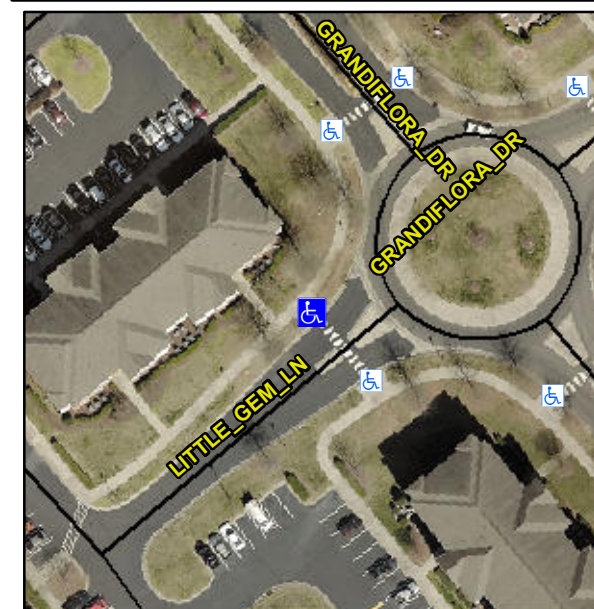
Not Found, R304.2.2, R304.5.3

Compliance	Description	Data	Compliance	Description	Data
N/A	Ramp Length (in)	94.0	No	Ramp Slope (%)	9.6
Yes	Ramp Width (in)	50.0	No	Ramp XSlope (%)	2.3
N/A	Flare Type LT	N/A	N/A	Flare Type RT	N/A
N/A	Flare Slope LT (%)	N/A	N/A	Flare Slope RT (%)	N/A
N/A	Flare Traversable LT?	N/A	N/A	Flare Traversable RT?	N/A
N/A	Landing Length (in)	N/A	N/A	DWS Provided?	N/A
N/A	Landing Width (in)	N/A	N/A	DWS Contrast?	N/A
N/A	Landing Slope (%)	N/A	N/A	DWS Length (in)	N/A
N/A	Landing X Slope (%)	N/A	N/A	DWS Full Width?	N/A
N/A	Landing Curb? (Y/N)	N/A	N/A	DWS Offset (in)	N/A
N/A	Shared Landing?	N/A			
N/A	Gutter Ponding?	N/A	N/A	Gutter Slope (%)	N/A
N/A	Gutter Lip Ht (in)	N/A	N/A	Gutter X Slope (%)	N/A
N/A	Painted X Walk1?	Yes	N/A	Painted X Walk2?	N/A
	X Walk 1 Direction	To SW		X Walk 2 Direction	N/A
N/A	X Walk 1 Width (in)	57.0	N/A	X Walk 2 Width (in)	N/A
	X Walk 1 Slope (%)	1.8		X Walk 2 Slope (%)	N/A
	X Walk 1 X Slope (%)	1.3		X Walk 2 X Slope (%)	N/A

N/A	Ramp inside XWalk1?	Yes	N/A	Ramp inside XWalk2?	N/A
	Road Slope (%)	N/A	N/A	Clear Space?	N/A
	Road X Slope (%)	N/A	N/A	Clear Space to XWalk (in)	N/A
N/A	Any Obstructions?	N/A	N/A	Storm Grate/Utility Hazard?	N/A
	Obstruction Type			Storm Grate/Utility Type	
		N/A			N/A
		Yes		Surface Condition? (G/P)	Good

Possible Solutions:

Remove & Replace Entire Ramp.
