Access Compliance Report

Public Rights-of-Way

(Curb Ramps)

Intersection ID: 10709	Main Street: MORSON_ST	Cross Street: PRYOR_ST	Location: NW
ADA ID: AC52E97CC4D8	Ramp Type: PerpDiag	Initial Pass/Fail: Fail	Overall Compliance: No
Severity Score: 13.75			
Codes/Mitigation Info/Possible Solution		Field Measurements/Component Compliance

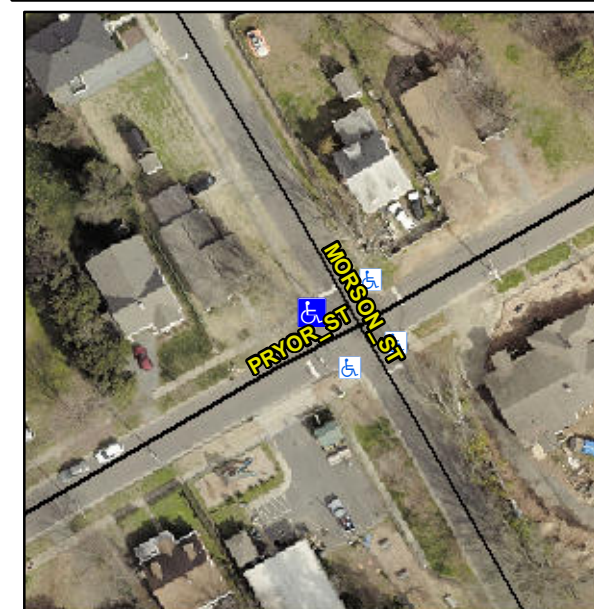
Not Found, R304.2.2, R304.5.3

Compliance	Description	Data	Compliance	Description	Data
N/A	Ramp Length (in)	68.0	No	Ramp Slope (%)	9.2
Yes	Ramp Width (in)	48.0	No	Ramp XSlope (%)	2.6
N/A	Flare Type LT	N/A	N/A	Flare Type RT	N/A
N/A	Flare Slope LT (%)	N/A	N/A	Flare Slope RT (%)	N/A
N/A	Flare Traversable LT?	N/A	N/A	Flare Traversable RT?	N/A
N/A	Landing Length (in)	N/A	N/A	DWS Provided?	N/A
N/A	Landing Width (in)	N/A	N/A	DWS Contrast?	N/A
N/A	Landing Slope (%)	N/A	N/A	DWS Length (in)	N/A
N/A	Landing X Slope (%)	N/A	N/A	DWS Full Width?	N/A
N/A	Landing Curb? (Y/N)	N/A	N/A	DWS Offset (in)	N/A
N/A	Shared Landing?	N/A			
N/A	Gutter Ponding?	N/A	N/A	Gutter Slope (%)	N/A
N/A	Gutter Lip Ht (in)	N/A	N/A	Gutter X Slope (%)	N/A
N/A	Painted X Walk1?	No	N/A	Painted X Walk2?	No
	X Walk 1 Direction	To S		X Walk 2 Direction	To E
N/A	X Walk 1 Width (in)	N/A	N/A	X Walk 2 Width (in)	N/A
	X Walk 1 Slope (%)	0.1		X Walk 2 Slope (%)	5.1
	X Walk 1 X Slope (%)	3.3		X Walk 2 X Slope (%)	0.2

N/A	Ramp inside XWalk1?	N/A	N/A	Ramp inside XWalk2?	N/A
	Road Slope (%)	3.2	N/A	Clear Space?	N/A
	Road X Slope (%)	5.2	N/A	Clear Space to XWalk (in)	N/A
N/A	Any Obstructions?	N/A	N/A	Storm Grate/Utility Hazard?	N/A
	Obstruction Type			Storm Grate/Utility Type	
		N/A			N/A
		Yes		Surface Condition? (G/P)	Good

Remove & Replace Curb Ramp With Two New Directional Ramps or Equivalent.
