Access Compliance Report

Public Rights-of-Way

(Curb Ramps)

Intersection ID: 6583	Main Street: FAIRES_FARM_RD	Cross Street: MCLEAN_RD	Location: E
ADA ID: AC582BE75311	Ramp Type: Perp	Initial Pass/Fail: Fail	Overall Compliance: No
			Severity Score: 13.75

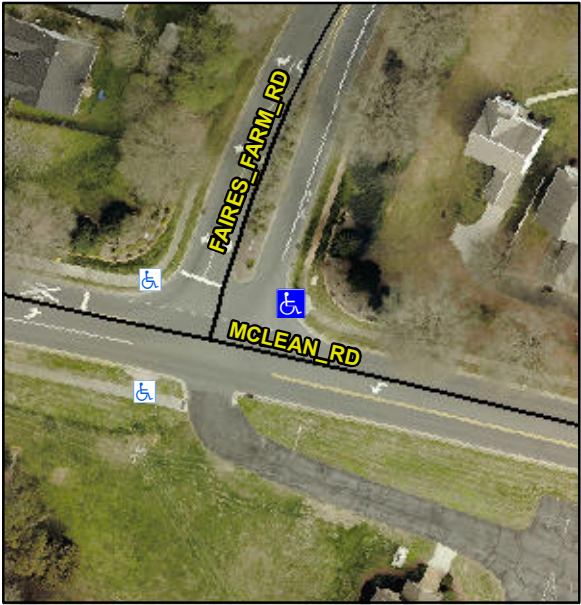
Possible Solutions:		Compliance	Description	Data
	Remove & Replace Entire Ramp.		N/A	Ramp Length (in)	59.0
			Yes	Ramp Width (in)	48.0
			N/A	Flare Type LT	N/A
			N/A	Flare Slope LT (%)	N/A
			N/A	Flare Traversable LT?	N/A
			N/A	Landing Length (in)	N/A
			N/A	Landing Width (in)	N/A
			N/A	Landing Slope (%)	N/A
			N/A	Landing X Slope (%)	N/A
<p>Surveyor Notes:</p> <p>N/A</p> <p>PROW/ADA:</p> <p>Not Found, R304.2.2, R304.5.3</p>			N/A	Flare Type RT	N/A
			N/A	Flare Slope RT (%)	N/A
			N/A	Flare Traversable RT?	N/A
			N/A	DWS Provided?	N/A
			N/A	DWS Contrast?	N/A
			N/A	DWS Length (in)	N/A
			N/A	DWS Full Width?	N/A
			N/A	DWS Offset (in)	N/A
			N/A	Shared Landing?	N/A
			N/A	Gutter Ponding?	N/A
			N/A	Gutter Lip Ht (in)	1.0
			N/A	Painted X Walk1?	No
				X Walk 1 Direction	To NW
			N/A	X Walk 1 Width (in)	N/A
				X Walk 1 Slope (%)	0.4

X Walk 1 X Slope (%)	3.2
			N/A	Ramp inside XWalk1?	N/A
			N/A	Ramp inside XWalk2?	N/A
			N/A	Road Slope (%)	N/A
			N/A	Road X Slope (%)	N/A
			N/A	Any Obstructions?	N/A
				Obstruction Type	
<p>Total Cost:</p> <p>\$ 1850.00</p>			N/A	Storm Grate/Utility Hazard?	N/A
				Storm Grate/Utility Type	
			N/A		N/A
			Yes	Surface Condition? (G/P)	Good
