Access Compliance Report Public Rights-of-Way (Curb Ramps)

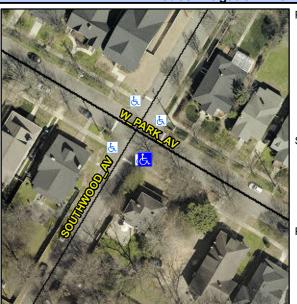
Total Cost:	\$ 1800.00

Field Measurements/Component Compliance								
Comp	liance Description	Data	Comp	oliance Description	Data			
N/A	Ramp Length (in)	52.0	N/A	Grade Break?	N/A			
Yes	Ramp Width (in)	60.0	N/A	Grade Break Slope (%)	0.0			
No	Ramp Slope (%)	9.0	N/A	Grade Break XSlope (%)	0.0			
Yes	Ramp XSlope (%)	1.7						
N/A	Flare Type LT	N/A	N/A	Flare Type RT	N/A			
N/A	Flare Slope LT (%)	N/A	N/A	Flare Slope RT (%)	0.0			
N/A	Flare Traversable LT?	N/A	N/A	Flare Traversable RT?	N/A			
N/A	Landing Length (in)	0.0	N/A	DWS Provided?	N/A			
N/A	Landing Width (in)	0.0	N/A	DWS Contrast?	N/A			
N/A	Landing Slope (%)	0.0	N/A	DWS Length (in)	N/A			
N/A	Landing X Slope (%)	0.0	N/A	DWS Full Width?	N/A			
N/A	Landing Curb? (Y/N)	N/A	N/A	DWS Offset LT (in)	N/A			
N/A	Shared Landing?	N/A	N/A	DWS Offset RT (in)	N/A			
N/A	Gutter Ponding?	0.0	N/A	Gutter Slope (%)	N/A			
N/A	Gutter Lip Ht (in)	0.0	N/A	Gutter X Slope (%)	N/A			
N/A	Painted X Walk1?	No		Road Slope (%)	4.1

Possible Solutions:

Remove & Replace Entire Ramp.
