Access Compliance Report

Public Rights-of-Way

(Curb Ramps)

Intersection ID: 27200	Main Street: ANNALEXA_LN	Cross Street: BALLANTYNE_COMMONS_PY	Location: NE
ADA ID: AC7F161D59B8	Ramp Type: Perp	Initial Pass/Fail: Fail	Overall Compliance: No
		Severity Score: 12.5

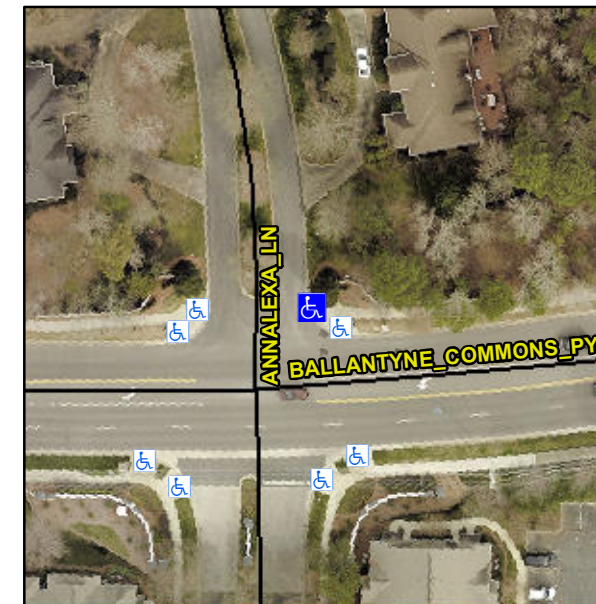
Compliance	Description	Data	Compliance	Description	Data
N/A	Ramp Length (in)	91.0	No	Ramp Slope (%)	9.3
Yes	Ramp Width (in)	48.0	Yes	Ramp XSlope (%)	1.8
N/A	Flare Type LT	N/A	N/A	Flare Type RT	N/A
N/A	Flare Slope LT (%)	N/A	N/A	Flare Slope RT (%)	N/A
N/A	Flare Traversable LT?	N/A	N/A	Flare Traversable RT?	N/A
N/A	Landing Length (in)	N/A	N/A	DWS Provided?	N/A
N/A	Landing Width (in)	N/A	N/A	DWS Contrast?	N/A
N/A	Landing Slope (%)	N/A	N/A	DWS Length (in)	N/A
N/A	Landing X Slope (%)	N/A	N/A	DWS Full Width?	N/A
N/A	Landing Curb? (Y/N)	N/A	N/A	DWS Offset (in)	N/A
N/A	Shared Landing?	N/A			
N/A	Gutter Ponding?	N/A	N/A	Gutter Slope (%)	N/A
N/A	Gutter Lip Ht (in)	N/A	N/A	Gutter X Slope (%)	N/A
N/A	Painted X Walk1?	No	N/A	Painted X Walk2?	N/A
	X Walk 1 Direction	To NW		X Walk 2 Direction	N/A
N/A	X Walk 1 Width (in)	N/A	N/A	X Walk 2 Width (in)	N/A
	X Walk 1 Slope (%)	5.0		X Walk 2 Slope (%)	N/A
	X Walk 1 X Slope (%)	1.3		X Walk 2 X Slope (%)	N/A

N/A	Ramp inside XWalk1?	N/A	N/A	Ramp inside XWalk2?	N/A
	Road Slope (%)	N/A	N/A	Clear Space?	N/A
	Road X Slope (%)	N/A	N/A	Clear Space to XWalk (in)	N/A
N/A	Any Obstructions?	N/A	N/A	Storm Grate/Utility Hazard?	N/A
	Obstruction Type			Storm Grate/Utility Type	
		N/A			N/A
			Yes	Surface Condition? (G/P)	Good

Possible Solutions:

Remove & Replace Entire Ramp.

R304.2.2

\$ 1850.00
