Access Compliance Report Public Rights-of-Way (Curb Ramps)

Intersection ID: 19463 Main Street: BARCLAY DOWNS DR Cross Street: SAYRE_RD Location: Ε ADA ID: AC8AE50A49AF Ramp Type: PerpDiag Initial Pass/Fail: Fail **Overall Compliance: No Severity Score:** 12.5

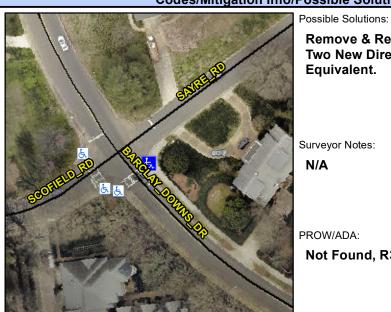
Not Found, R304.2.2

| N/A | Ramp Length (in) | 49.0 | No | Ramp Slope (%) | 8.5 |
| Yes | Ramp Width (in) | 49.0 | Yes | Ramp XSlope (%) | 1.8 |

Remove & Replace Curb Ramp With Two New Directional Ramps or Equivalent.
