# Access Compliance Report

## Public Rights-of-Way

| Intersection ID: 19931 | Main Street: CARNEGIE_BV | Cross Street: ASSEMBLY ST | Location: SE |
| ADA ID: AC90E5118866 | Ramp Type: Perp | Initial Pass/Fail: Fail | Overall Compliance: No |

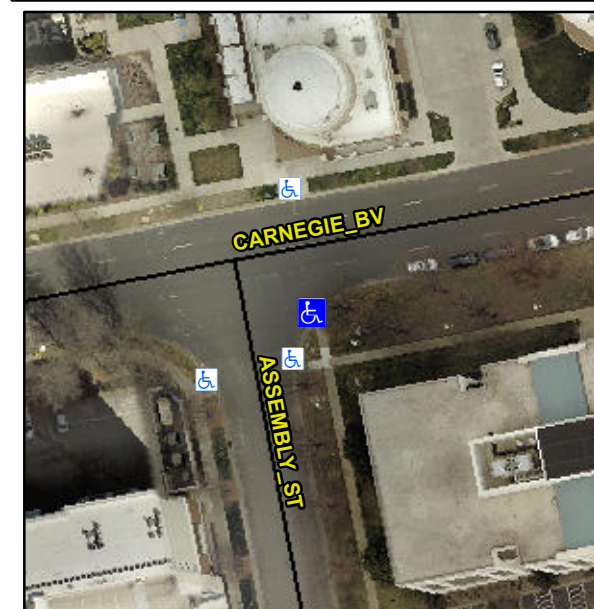
| Severity Score: 50 | | | |

| Compliance | Description | Data | Compliance | Description | Data |
|---|---|---|---|---|---|
| N/A | Ramp Length (in) | 66.0 | No | Ramp Slope (%) | 14.9 |
| Yes | Ramp Width (in) | 48.0 | No | Ramp XSlope (%) | 7.2 |

**Remove & Replace Entire Ramp.**

**R304.2.2, R304.5.3**

**\$ 1850.00**
