Access Compliance Report Public Rights-of-Way (Curb Ramps)

Intersection ID: 5905 Main Street: HELLEBORE RD Cross Street: PIMPERNEL RD Location: NE **Overall Compliance: No** ADA ID: AC966DC2AF80 Ramp Type: Perp Initial Pass/Fail: Fail Severity Score: 13.75

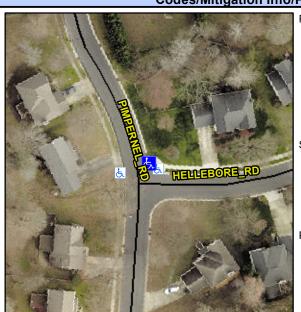
N/A Flare Slope LT (%) N/A N/A Flare Slope RT (%) N/A N/A Flare Traversable LT? N/A N/A Flare Traversable RT? N/A N/A Landing Length (in) N/A N/A **DWS Provided?** N/A N/A Landing Width (in) N/A N/A **DWS Contrast?** N/A N/A N/A N/A Landing Slope (%) DWS Length (in) N/A N/A Landing X Slope (%) N/A N/A DWS Full Width? N/A N/A Landing Curb? (Y/N) N/A N/A DWS Offset (in) N/A N/A N/A Shared Landing? N/A **Gutter Ponding?** N/A N/A Gutter Slope (%) N/A N/A Gutter Lip Ht (in) N/A N/A Gutter X Slope (%) N/A N/A Painted X Walk1? No N/A Painted X Walk2? N/A X Walk 1 Direction To W X Walk 2 Direction N/A N/A N/A X Walk 1 Width (in) X Walk 2 Width (in) N/A X Walk 1 Slope (%) X Walk 2 Slope (%) N/A 4.1 X Walk 1 X Slope (%) 3.7 X Walk 2 X Slope (%) N/A N/A N/A N/A Ramp inside XWalk2? Ramp inside XWalk1? N/A Road Slope (%) N/A N/A Clear Space? N/A N/A Road X Slope (%) N/A Clear Space to XWalk (in) N/A N/A N/A Any Obstructions? N/A Storm Grate/Utility Hazard? N/A **Obstruction Type** Storm Grate/Utility Type N/A N/A Yes Surface Condition? (G/P) Good

Possible Solutions: Remove & Replace Entire Ramp. Surveyor Notes: N/A PROW/ADA: R304.2.2
