# Access Compliance Report

## Public Rights-of-Way

### (Curb Ramps)

Intersection ID: 11306	Main Street: W_9TH_ST	Cross Street: N_SMITH_ST	Location: E
ADA ID: AC98197B0751	Ramp Type: PerpDiag	Initial Pass/Fail: Fail	Overall Compliance: No
		Severity Score: 10

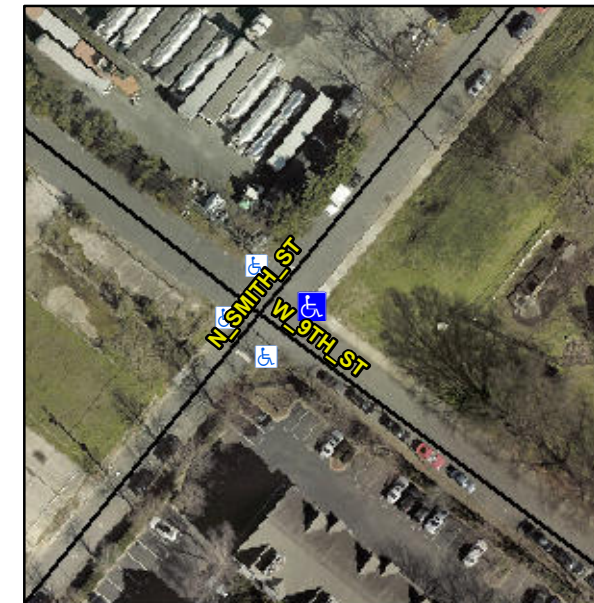
Compliance	Description	Data	Compliance	Description	Data
N/A	Ramp Length (in)	66.0	Yes	Ramp Slope (%)	7.8
No	Ramp Width (in)	36.0	No	Ramp XSlope (%)	4.8
N/A	Flare Type LT	N/A	N/A	Flare Type RT	N/A
N/A	Flare Slope LT (%)	N/A	N/A	Flare Slope RT (%)	N/A
N/A	Flare Traversable LT?	N/A	N/A	Flare Traversable RT?	N/A
N/A	Landing Length (in)	N/A	N/A	DWS Provided?	N/A
N/A	Landing Width (in)	N/A	N/A	DWS Contrast?	N/A
N/A	Landing Slope (%)	N/A	N/A	DWS Length (in)	N/A
N/A	Landing X Slope (%)	N/A	N/A	DWS Full Width?	N/A
N/A	Landing Curb? (Y/N)	N/A	N/A	DWS Offset (in)	N/A
N/A	Shared Landing?	N/A			
N/A	Gutter Ponding?	N/A	N/A	Gutter Slope (%)	N/A
N/A	Gutter Lip Ht (in)	2.0	N/A	Gutter X Slope (%)	N/A
N/A	Painted X Walk1?	No	N/A	Painted X Walk2?	No
	X Walk 1 Direction	To NW		X Walk 2 Direction	To SW
N/A	X Walk 1 Width (in)	N/A	N/A	X Walk 2 Width (in)	N/A
	X Walk 1 Slope (%)	3.7		X Walk 2 Slope (%)	6.3
	X Walk 1 X Slope (%)	1.7		X Walk 2 X Slope (%)	0.5

N/A	Ramp inside XWalk1?	N/A	N/A	Ramp inside XWalk2?	N/A
	Road Slope (%)	3.7	N/A	Clear Space?	N/A
	Road X Slope (%)	4.6	N/A	Clear Space to XWalk (in)	N/A
N/A	Any Obstructions?	N/A	N/A	Storm Grate/Utility Hazard?	N/A
	Obstruction Type			Storm Grate/Utility Type	
		N/A			N/A
		Yes		Surface Condition? (G/P)	Good

**Remove & Replace Curb Ramp With Two New Directional Ramps or Equivalent.**

**R304.5.1, R304.5.3**
