## Access Compliance Report Public Rights-of-Way (Curb Ramps)

Intersection ID: 6716 Main Street: ATLAS\_DR Cross Street: GREENLOCH\_CT Location: N

ADA ID: ACADADA2847D Ramp Type: BlendTrans1 Initial Pass/Fail: Fail Overall Compliance: No Severity Score: 8.75

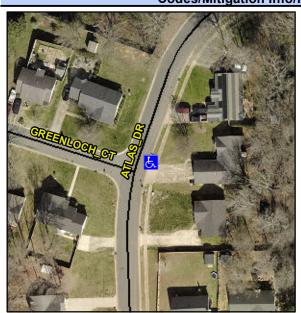
Not Found, R304.5.1

Compliance Description Data Compliance Description Yes BlendTrans Slope (%) N/A Ramp Length (in) 48.0 Yes No Ramp Width (in) 36.0 BlendTrans XSlope (%) N/A N/A Flare Type LT N/A Flare Type RT N/A Flare Slope LT (%) N/A N/A Flare Slope RT (%) N/A Flare Traversable LT? N/A N/A Flare Traversable RT? N/A Landing Length (in) N/A N/A **DWS Provided?** N/A Landing Width (in) N/A N/A **DWS Contrast?** N/A N/A N/A Landing Slope (%) DWS Length (in) N/A Landing X Slope (%) N/A N/A DWS Full Width? N/A Landing Curb? (Y/N) N/A N/A DWS Offset (in) N/A N/A Shared Landing? N/A **Gutter Ponding?** N/A N/A Gutter Slope (%) N/A Gutter Lip Ht (in) N/A N/A Gutter X Slope (%) N/A Painted X Walk1? No N/A Painted X Walk2? X Walk 1 Direction To S X Walk 2 Direction N/A X Walk 1 Width (in) X Walk 2 Width (in) X Walk 1 Slope (%) 3.0 X Walk 2 Slope (%) X Walk 1 X Slope (%) 1.2 X Walk 2 X Slope (%) N/A N/A Ramp inside XWalk2? N/A Ramp inside XWalk1? Road Slope (%) 1.2 Clear Space? N/A Road X Slope (%) Clear Space to XWalk (in) 3.0 N/A N/A N/A Any Obstructions? Storm Grate/Utility Hazard?

Remove & Replace Curb Ramp With
Two New Directional Ramps or
Equivalent.
