Access Compliance Report

Public Rights-of-Way

(Curb Ramps)

| Intersection ID: 3307 | Main Street: SUTTONVIEW_DR | Cross Street: LOOKOUT_POINT_DR | Location: E |

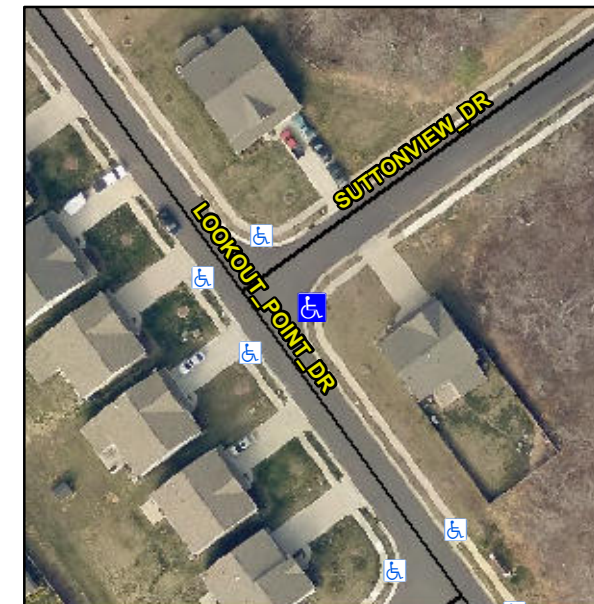
| ADA ID: ACB4F37C32C4 | Ramp Type: PerpDiag | Initial Pass/Fail: Fail | Overall Compliance: No |
| Severity Score: 10 | | | |

Not Found, R304.5.1, R304.5.3

| Compliance | Description | Data | Compliance | Description | Data |
|---|---|---|---|---|---|
| N/A | Ramp Length (in) | 49.0 | Yes | Ramp Slope (%) | 5.8 |
| No | Ramp Width (in) | 47.5 | No | Ramp XSlope (%) | 4.1 |

Remove & Replace Curb Ramp With Two New Directional Ramps or Equivalent.

Total Cost: \$ 3200.00
