Access Compliance Report

Public Rights-of-Way

(Curb Ramps)

Intersection ID: 7375	Main Street: N_TRYON_ST	Cross Street: TOM_HUNTER_RD	Location: SW
ADA ID: ACB583C1A25E	Ramp Type: Perp	Initial Pass/Fail: Pass	Overall Compliance: Yes
Severity Score: 0			
Codes/Mitigation Info/Possible Solution		Field Measurements/Component Compliance

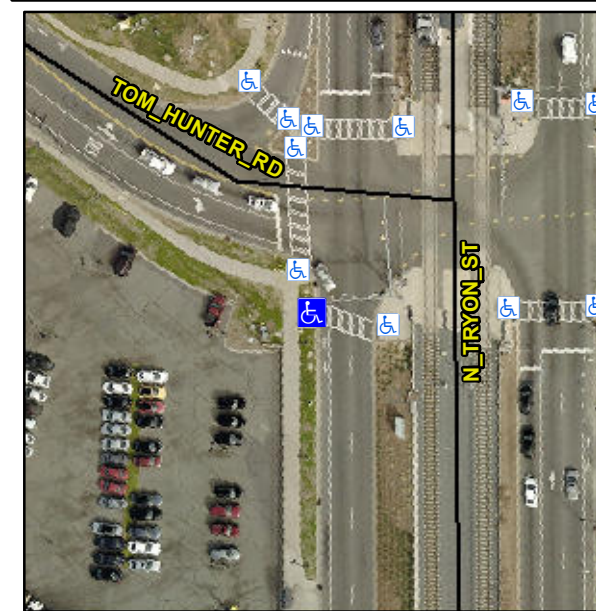
Compliance	Description	Data	Compliance	Description	Data
N/A	Ramp Length (in)	98.0	Yes	Ramp Slope (%)	7.5
Yes	Ramp Width (in)	48.0	Yes	Ramp XSlope (%)	0.6
N/A	Flare Type LT	Sloped	N/A	Flare Type RT	N/A
N/A	Flare Slope LT (%)	6.5	N/A	Flare Slope RT (%)	5.1
N/A	Flare Traversable LT?	No	N/A	Flare Traversable RT?	No
Yes	Landing Length (in)	97.0	Yes	DWS Provided?	Yes
Yes	Landing Width (in)	48.0	Yes	DWS Contrast?	Yes
Yes	Landing Slope (%)	1.4	Yes	DWS Length (in)	24.0
Yes	Landing X Slope (%)	0.6	Yes	DWS Full Width?	Yes
N/A	Landing Curb? (Y/N)	No	Yes	DWS Offset (in)	2.0
N/A	Shared Landing?	No			
Yes	Gutter Ponding?	No	Yes	Gutter Slope (%)	3.3
Yes	Gutter Lip Ht (in)	0.0	Yes	Gutter X Slope (%)	0.2
N/A	Painted X Walk1?	Yes	N/A	Painted X Walk2?	N/A
	X Walk 1 Direction	To E		X Walk 2 Direction	N/A
N/A	X Walk 1 Width (in)	113.0	N/A	X Walk 2 Width (in)	N/A
	X Walk 1 Slope (%)	2.7		X Walk 2 Slope (%)	N/A
	X Walk 1 X Slope (%)	0.5		X Walk 2 X Slope (%)	N/A

Yes	Ramp inside XWalk1?	Yes	N/A	Ramp inside XWalk2?	N/A
	Road Slope (%)	N/A	N/A	Clear Space?	Yes
	Road X Slope (%)	N/A	N/A	Clear Space to XWalk (in)	N/A
Yes	Any Obstructions?	No	Yes	Storm Grate/Utility Hazard?	No
	Obstruction Type			Storm Grate/Utility Type	
		N/A			N/A
			Yes	Surface Condition? (G/P)	Good

Possible Solutions:

N/A
