Access Compliance Report

Public Rights-of-Way

(Curb Ramps)

Intersection ID: 11838	Main Street: MECKLENBURG_AV	Cross Street: LYNHAVEN_ST	Location: NE
ADA ID: ACBE25EFB83C	Ramp Type: Directional1	Initial Pass/Fail: Fail	Overall Compliance: No
Severity Score: 12.5			
Codes/Mitigation Info/Possible Solution		Field Measurements/Component Compliance

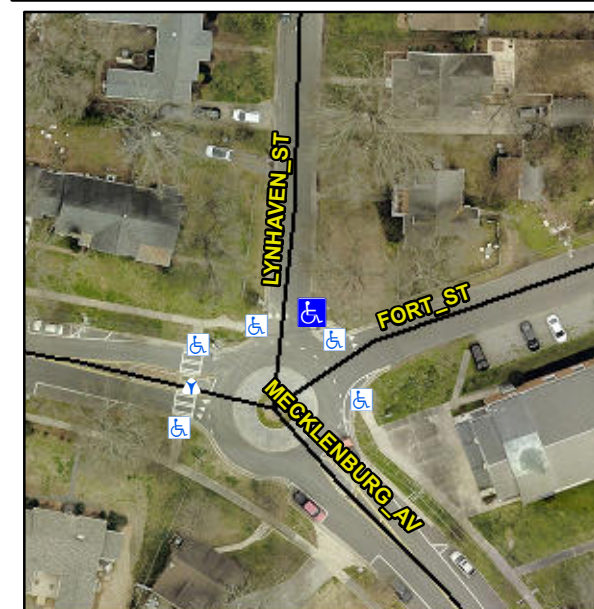
Compliance	Description	Data	Compliance	Description	Data
N/A	Ramp Length (in)	68.0	N/A	Grade Break?	N/A
Yes	Ramp Width (in)	55.5	N/A	Grade Break Slope (%)	0.0
No	Ramp Slope (%)	8.8	N/A	Grade Break XSlope (%)	0.0
Yes	Ramp XSlope (%)	0.7			
N/A	Flare Type LT	N/A	N/A	Flare Type RT	N/A
N/A	Flare Slope LT (%)	N/A	N/A	Flare Slope RT (%)	0.0
N/A	Flare Traversable LT?	N/A	N/A	Flare Traversable RT?	N/A
N/A	Landing Length (in)	0.0	N/A	DWS Provided?	N/A
N/A	Landing Width (in)	0.0	N/A	DWS Contrast?	N/A
N/A	Landing Slope (%)	0.0	N/A	DWS Length (in)	N/A
N/A	Landing X Slope (%)	0.0	N/A	DWS Full Width?	N/A
N/A	Landing Curb? (Y/N)	N/A	N/A	DWS Offset LT (in)	N/A
N/A	Shared Landing?	N/A	N/A	DWS Offset RT (in)	N/A
N/A	Gutter Ponding?	0.0	N/A	Gutter Slope (%)	N/A
N/A	Gutter Lip Ht (in)	0.0	N/A	Gutter X Slope (%)	N/A
N/A	Painted X Walk1?	No		Road Slope (%)	1.1
	X Walk 1 Direction	To W		Road X Slope (%)	1.9
	X Walk 1 Width (in)	N/A		Clear Space?	N/A

Remove & Replace Entire Ramp.

R304.2.2
