# Access Compliance Report

## Public Rights-of-Way

### (Curb Ramps)

Intersection ID: 11912	Main Street: W_1ST_ST	Cross Street: MCNINCH_ST	Location: W
ADA ID: ACCA27063247	Ramp Type: Directional1	Initial Pass/Fail: Fail	Overall Compliance: No
Severity Score: 13.75			
Codes/Mitigation Info/Possible Solution		Field Measurements/Component Compliance

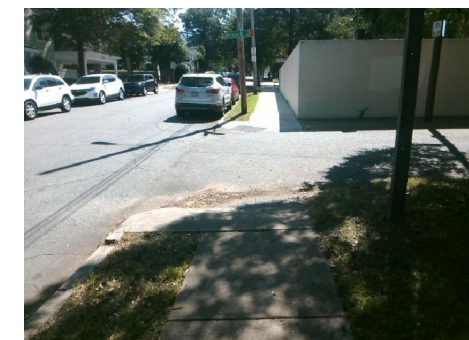
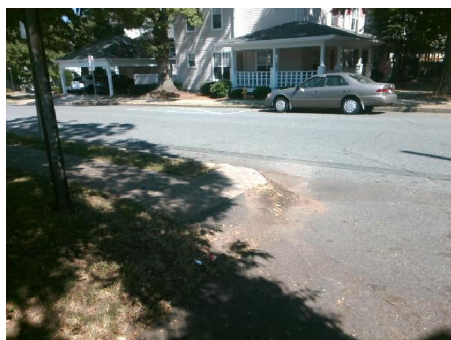
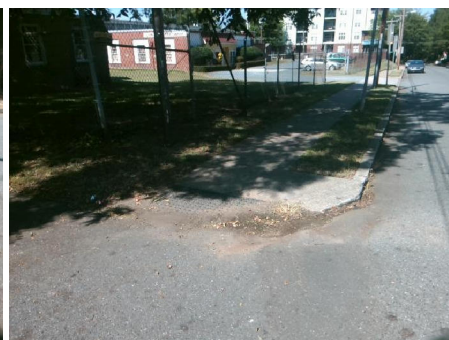
**PONDING**

Compliance	Description	Data	Compliance	Description	Data
N/A	Ramp Length (in)	60.0	N/A	Grade Break?	N/A
Yes	Ramp Width (in)	48.0	N/A	Grade Break Slope (%)	0.0
No	Ramp Slope (%)	9.8	N/A	Grade Break XSlope (%)	0.0
No	Ramp XSlope (%)	2.1			
N/A	Flare Type LT	N/A	N/A	Flare Type RT	N/A
N/A	Flare Slope LT (%)	N/A	N/A	Flare Slope RT (%)	0.0
N/A	Flare Traversable LT?	N/A	N/A	Flare Traversable RT?	N/A
N/A	Landing Length (in)	0.0	N/A	DWS Provided?	N/A
N/A	Landing Width (in)	0.0	N/A	DWS Contrast?	N/A
N/A	Landing Slope (%)	0.0	N/A	DWS Length (in)	N/A
N/A	Landing X Slope (%)	0.0	N/A	DWS Full Width?	N/A
N/A	Landing Curb? (Y/N)	N/A	N/A	DWS Offset LT (in)	N/A
N/A	Shared Landing?	N/A	N/A	DWS Offset RT (in)	N/A
N/A	Gutter Ponding?	0.0	N/A	Gutter Slope (%)	N/A
N/A	Gutter Lip Ht (in)	0.0	N/A	Gutter X Slope (%)	N/A
N/A	Painted X Walk1?	No		Road Slope (%)	5.8
	X Walk 1 Direction	To SE		Road X Slope (%)	0.8
	X Walk 1 Width (in)	N/A		Clear Space?	N/A

X Walk 1 Slope (%)	5.8	N/A	Clear Space to XWalk (in)	N/A
	X Walk 1 X Slope (%)	0.8	N/A	Storm Grate/Utility Hazard?	N/A
N/A	Ramp inside XWalk1?	N/A		Storm Grate/Utility Type	
N/A	Any Obstructions?	N/A			N/A
	Obstruction Type		Yes	Surface Condition? (G/P)	Good
			N/A	Curb Slope (%)	2.1

**Remove & Replace Entire Ramp.**
